# Rates and processes of stream bank erosion and its contribution to suspended sediment load, Big Spring Run, PA

**Andrea Shilling**  
**Earth and Environment Department**  
**Franklin & Marshall College**

*Advisor: Dorothy Merritts, Earth and Environment*  
*Franklin & Marshall College*  
*GEO490: Independent Study*  
*Project Submission: May 7, 2009*  
*Graduation: May 15, 2010*

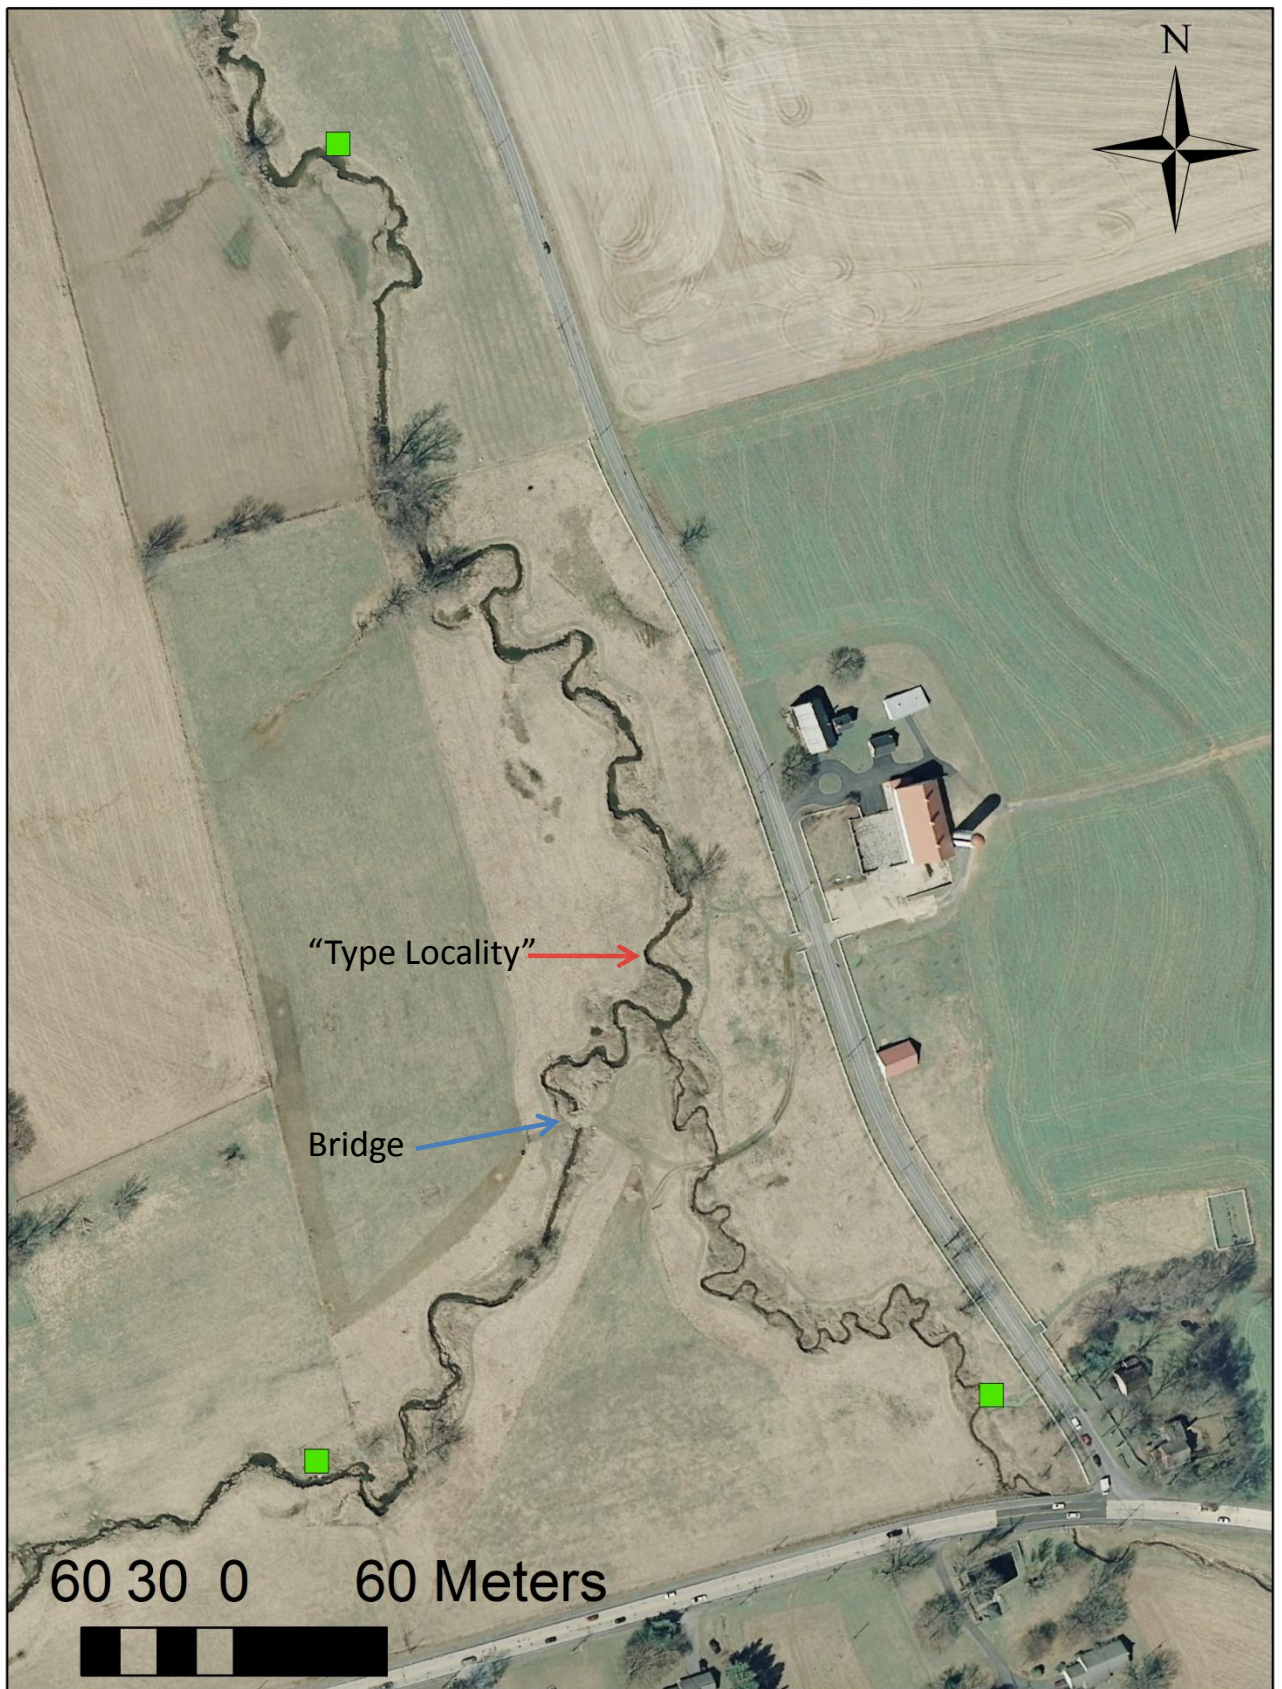
Figure 1. BSR study reach with the three U.S.G.S. gage stations, represented by green squares, collecting continuous data on water level, temperature, and turbidity.

This paper presents the results of research focused on quantifying key elements of a sediment budget for a portion of the Big Spring Run (BSR) watershed (Figure 1). The objective of this research is to measure the amount of fine-grained sediment eroded and deposited along stream banks within the study reach, and to compare this amount to the flux of fine-grained sediment measured at U. S. Geological Survey (USGS) gage stations located up and down stream of this reach.

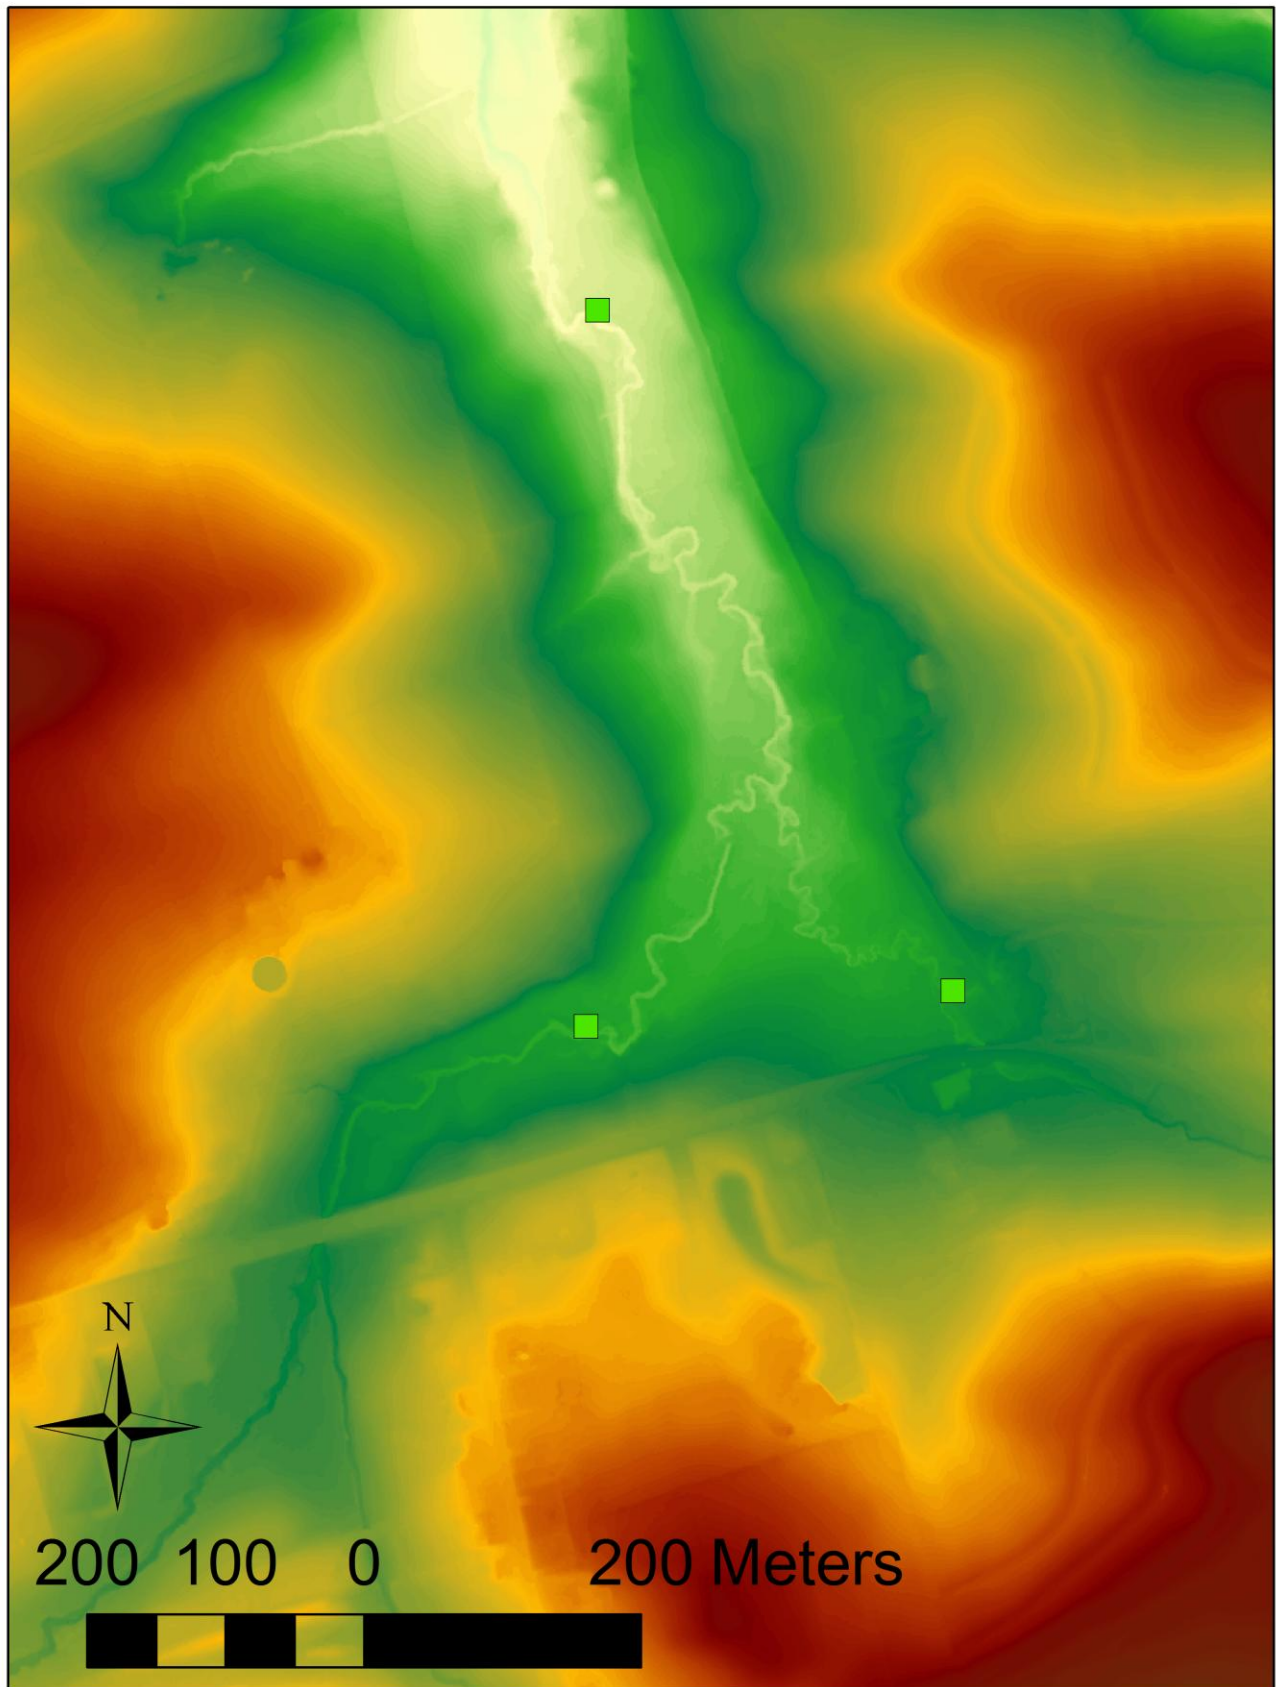
Figure 2. Topographic map generated from lidar elevation data for BSR study reach. Green squares show locations of the three U.S.G.S. gage stations. The highest elevation, in deep red, is 122 m; lowest elevation along channel near northernmost gage station, in pale green, is 92 m.

The topography of the BSR region is one of low to moderate relief with broad rolling hills and valleys (Galeone et al, 2006; see Figure 2 for a topographic map of BSR). The

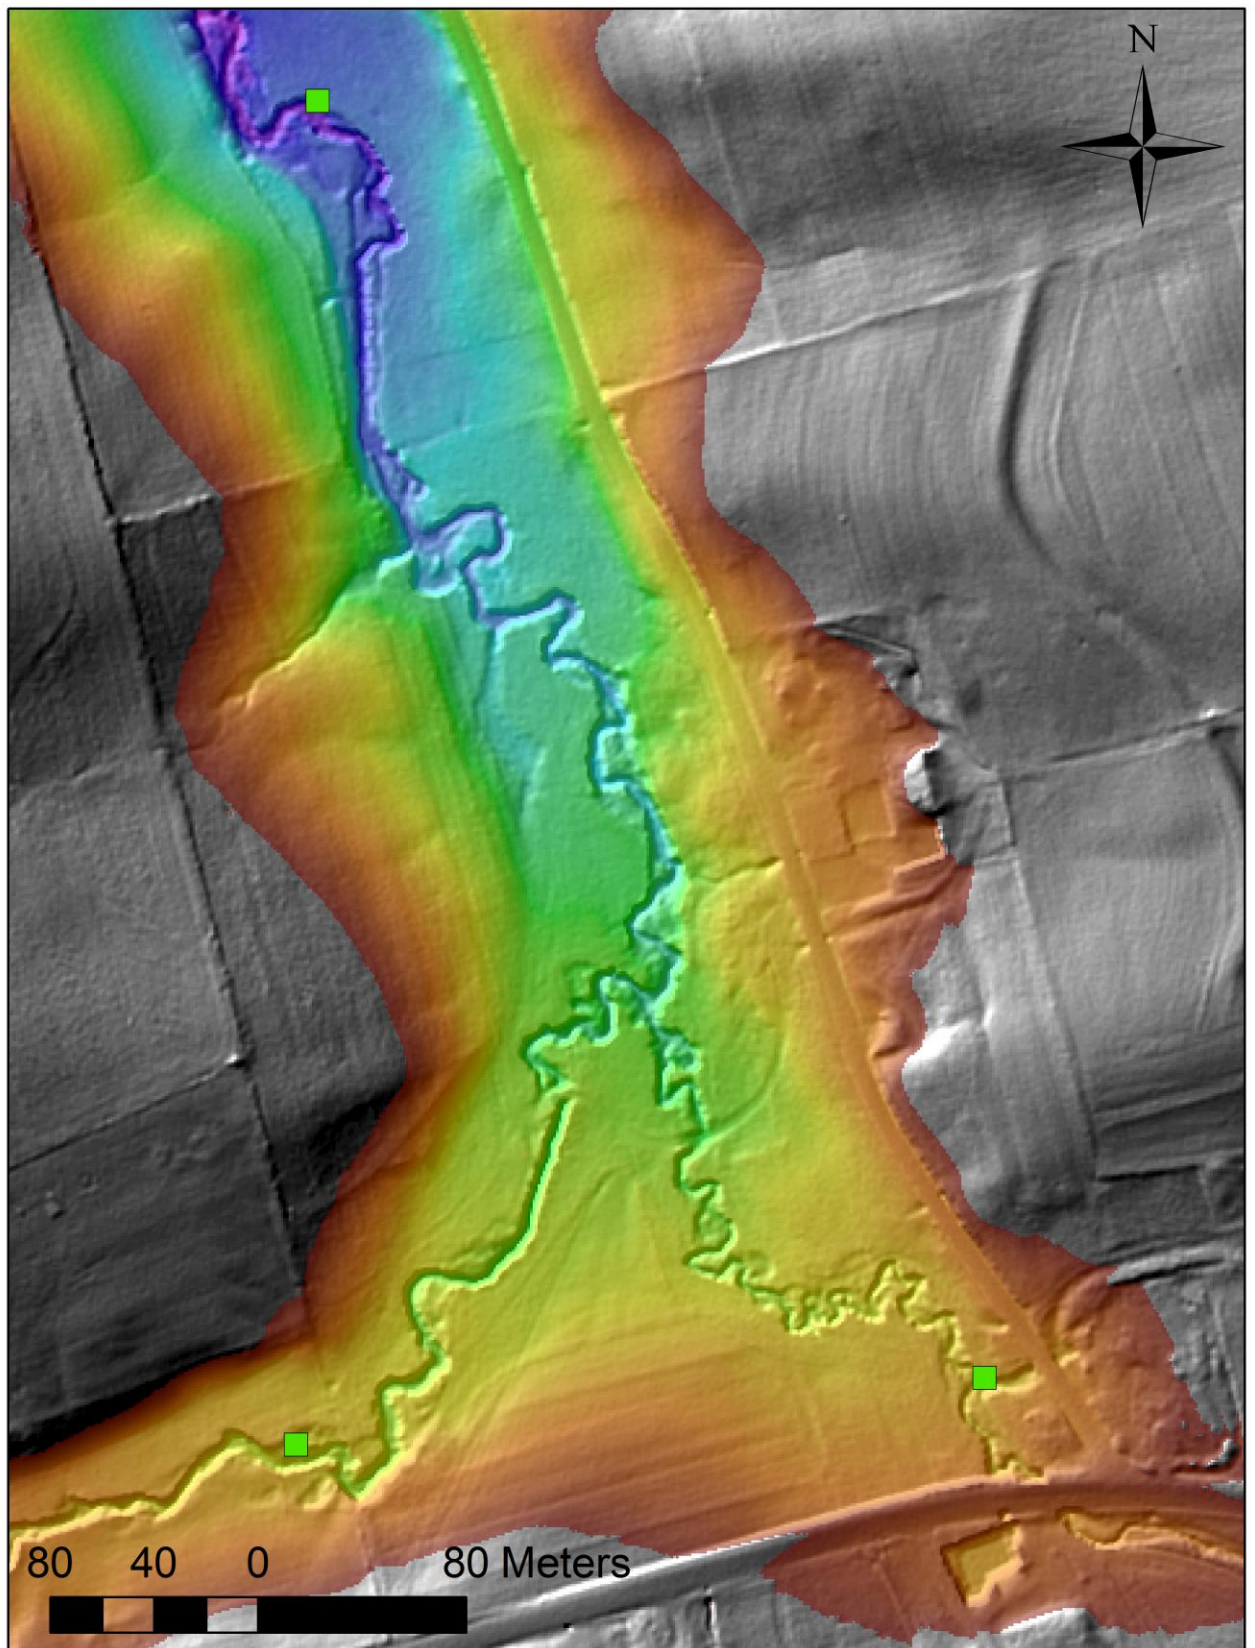
Figure 3. Elevation data from 2008 lidar for the valley bottom draped above hill shade relief.

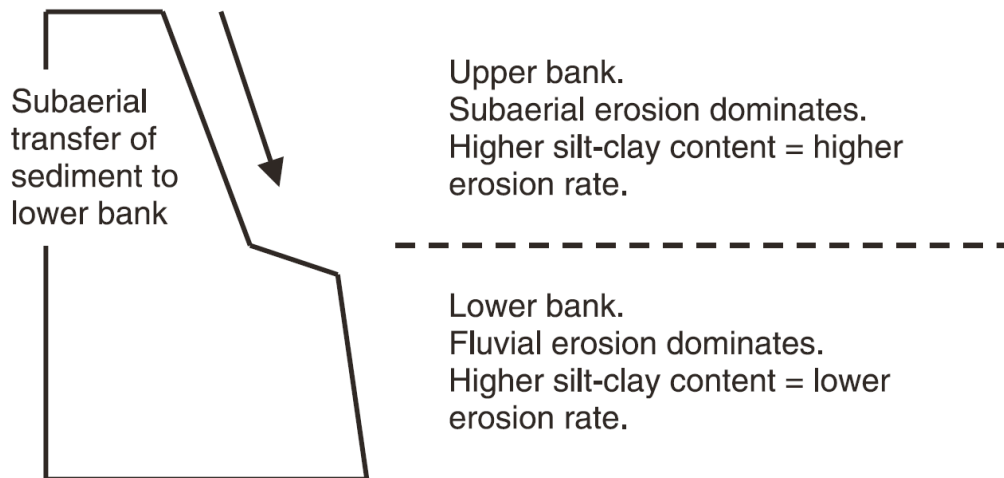
Figure 4. Diagram showing how subaerial processes aid in the transfer and erosion of sediment in cohesive banks (those with high silt-clay content). Adapted from Couper (2003) Figure 8.

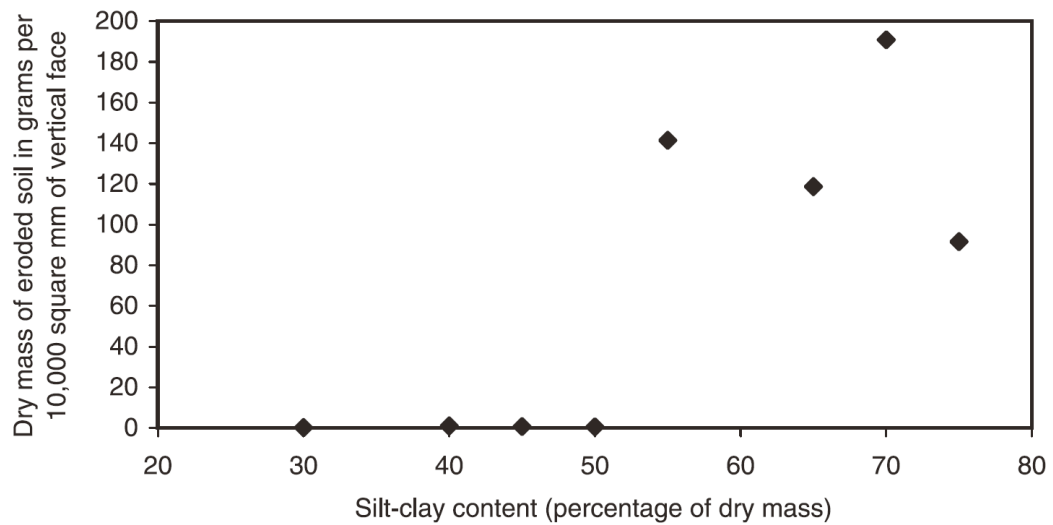
Figure 5. Graph showing how erodability increases with silt-clay content. Adapted from Couper (2003) Figure 5.

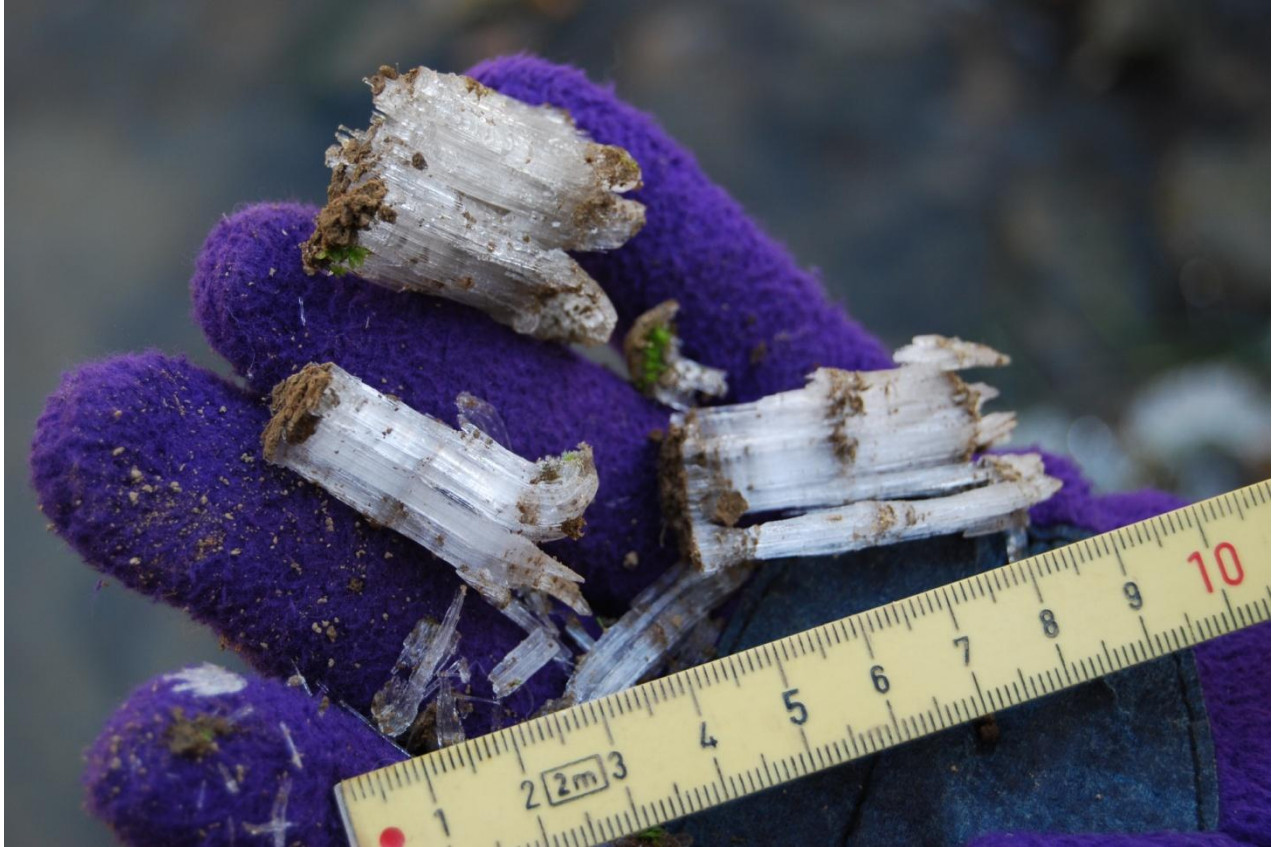
Figure 6. Photograph of needle ice removed from the banks of BSR. Metric ruler for scale.

A common subaerial process that disaggregates bank material is associated with the formation of needle ice (Figure 6). Needle ice is a cryogenic phenomenon that occurs when conditions are right for the formation of needles of ice within soil. Needle ice has been described by Washburn (1979:92) as the "accumulation of slender, bristle-like ice crystals", or needles, either at or just below the ground surface. These filaments of ice are about 1 mm<sup>2</sup> in cross

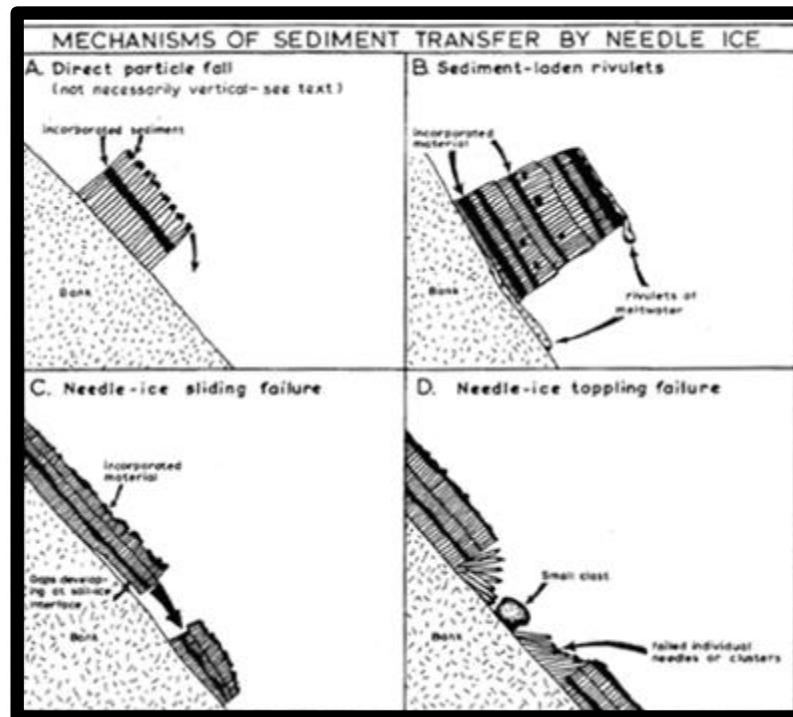
Figure 7. Illustration showing mechanisms of sediment transfer by needle ice. Adapted from Lawler et al, 1997.

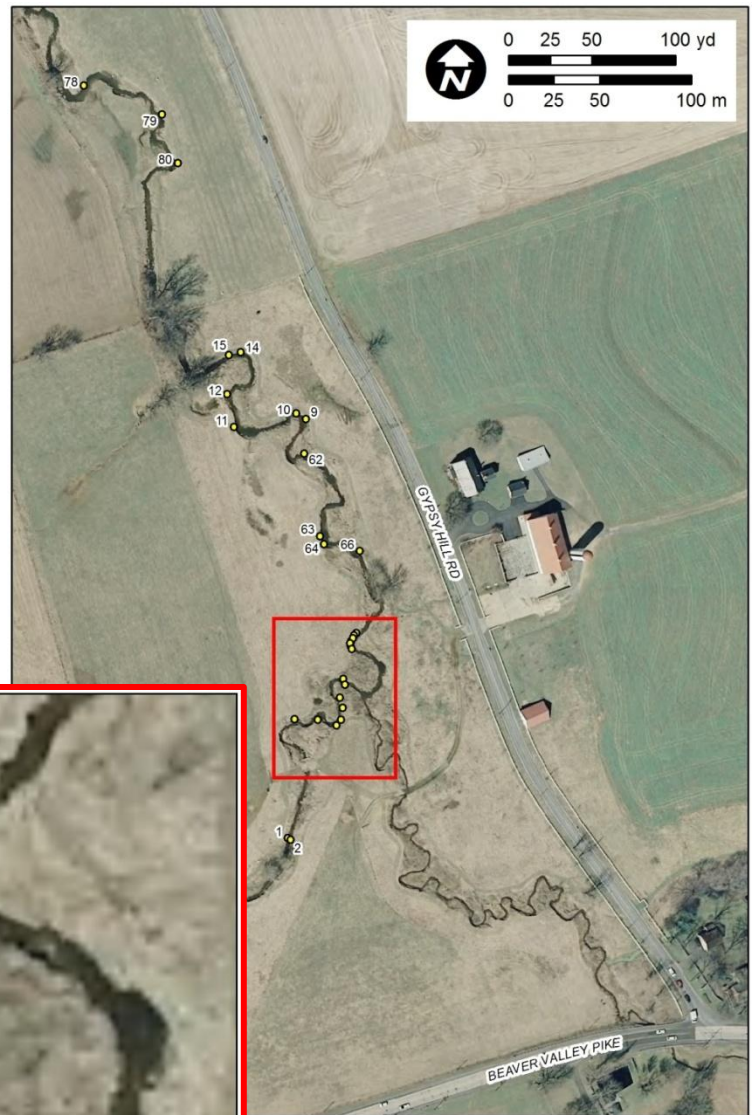
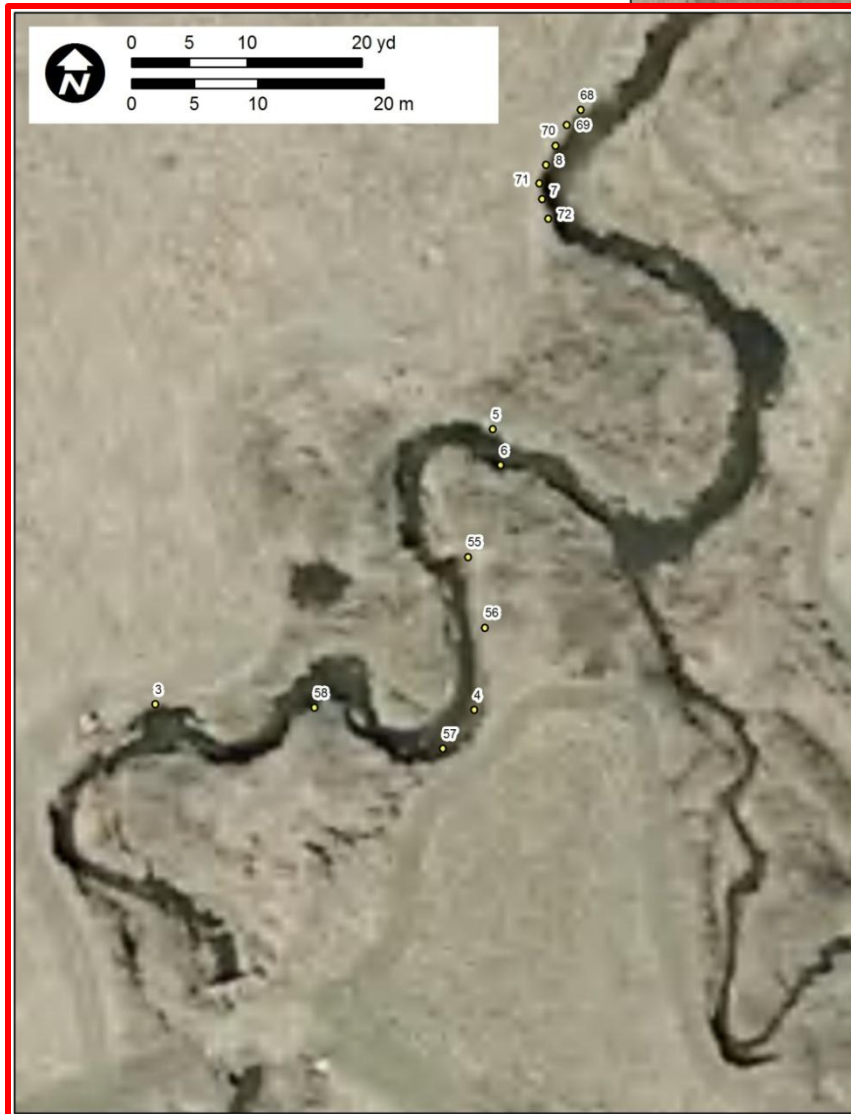
Figures 8 & 9. Digital orthoimage (2008) showing the placement and identification of erosion pins along BSR. Inset photo below shows area of dense pins. Location of inset photo is shown as red box at right.

Erosion pins were installed at different stream bank locations of BSR over the course of two years. Data has been collected on each pin since installation (Figures 8 and 9). When the pins were first installed the distance from the top of the bank to each pin was measured and recorded. The erosion pins, which consist of ¼-inch diameter rebar stakes measuring 4 ft in length, are pounded into the bank leaving a certain length exposed. Some of the early pins used were 2 ft in length. These were replaced with 4-ft pins within a year. When originally installed the amount of pin left exposed was recorded and every time the pin was measured the data were compiled in an excel spreadsheet. From May 2008 to September 2009, pins were installed and monitored at 35 sites along BSR. At each of these sites three (sometimes four) pins were installed in an evenly spaced line from the top of the bank to water level. Pins were measured at intervals of about one time per month with a cm-scale ruler. Measurement error is estimated to be  $\sim\pm 1$  cm.

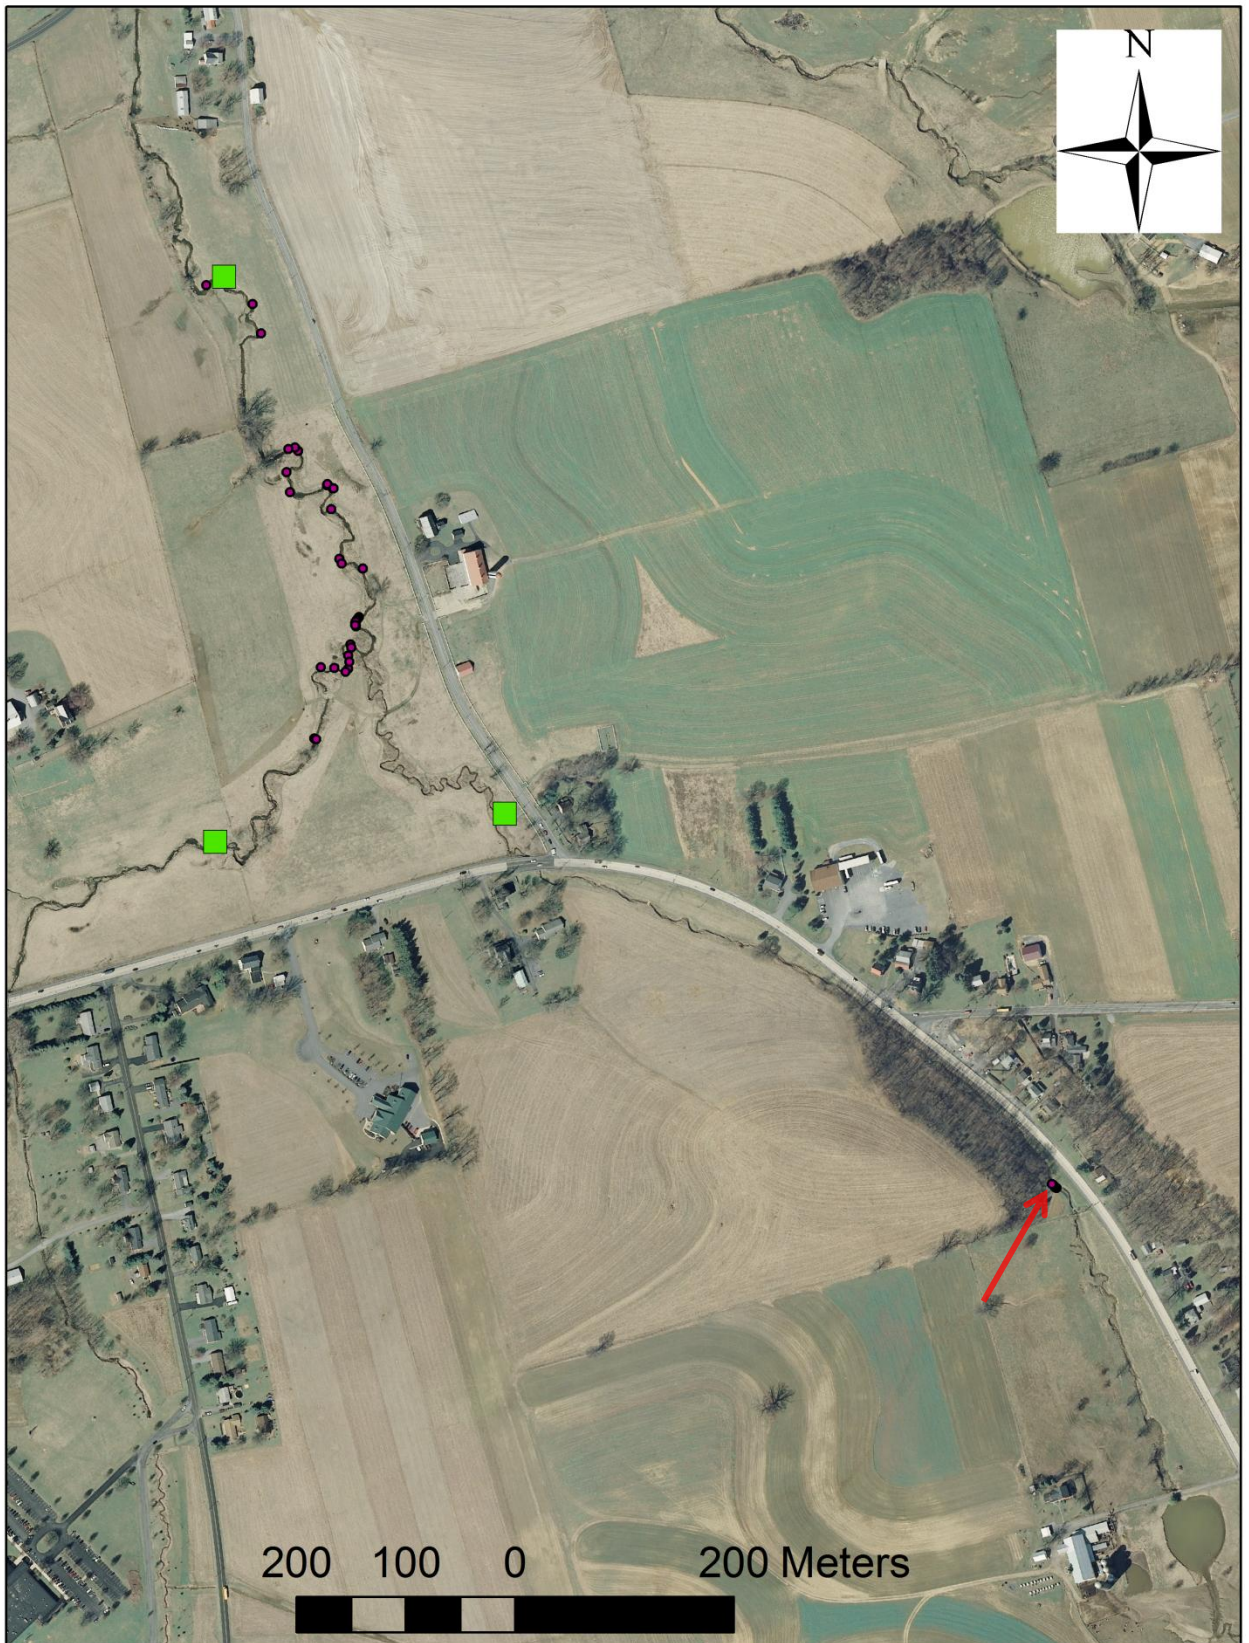
Figure 10. Digital orthoimage showing the location of the “Houser Grid Site” in relation to the BSR study reach. Location indicated by a red arrow.

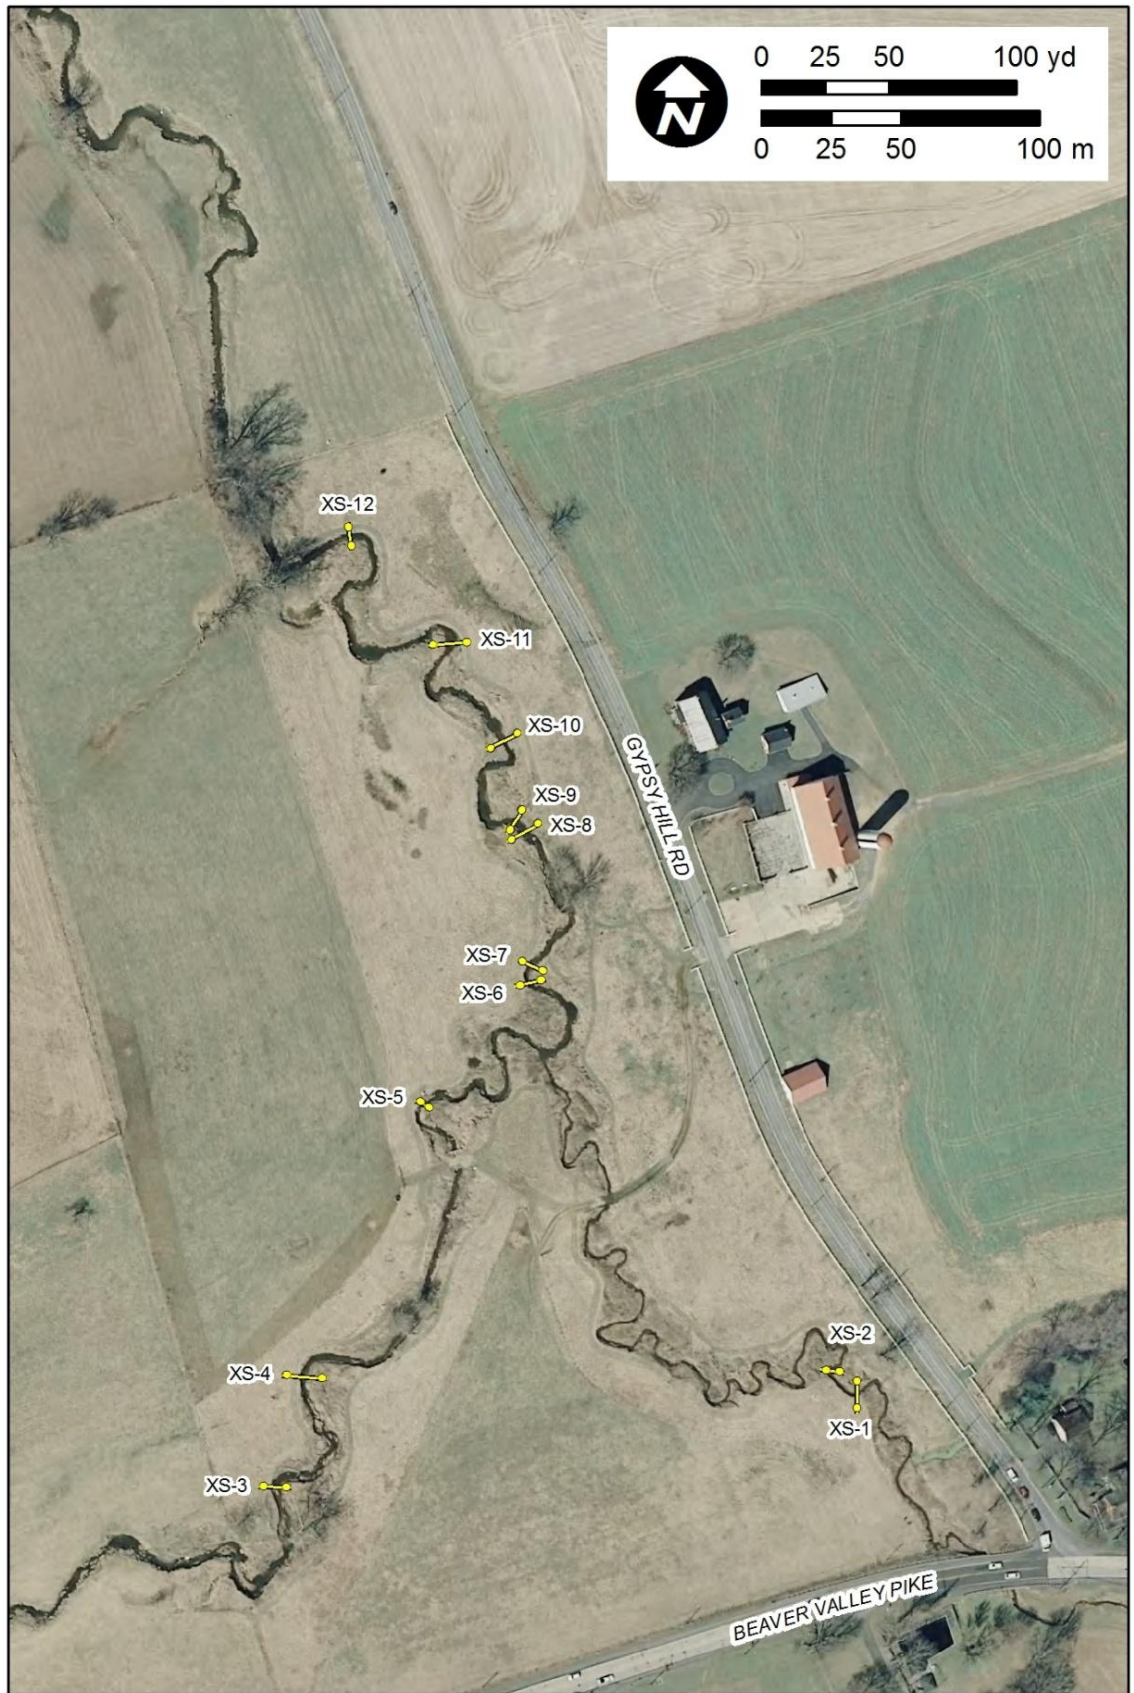
Figure 11. Digital orthoimage (2008) showing the location of cross sections surveyed in 2004 and 2010.

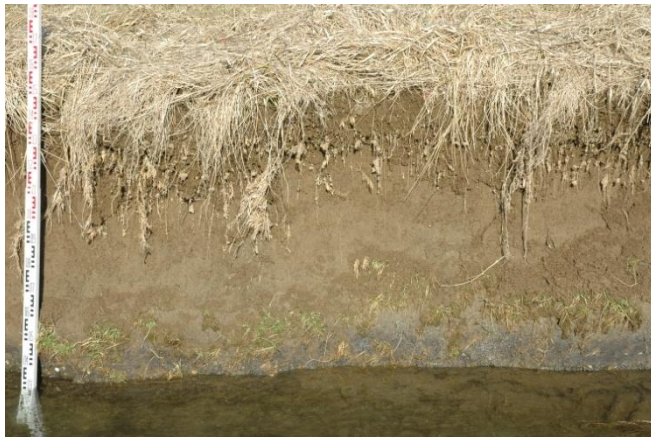
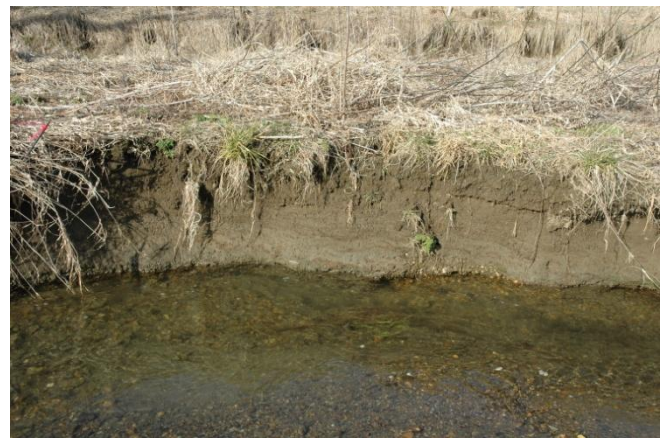
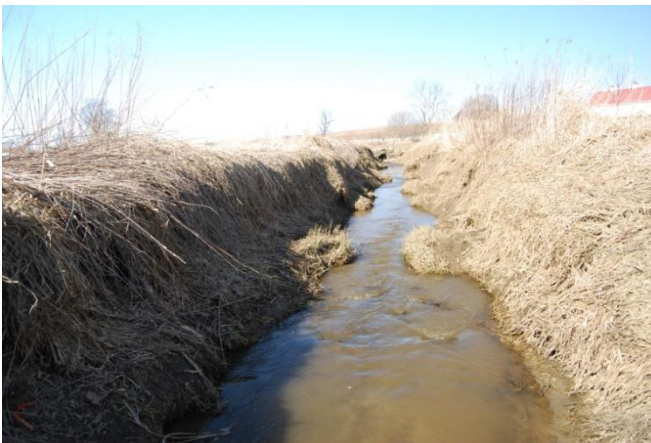
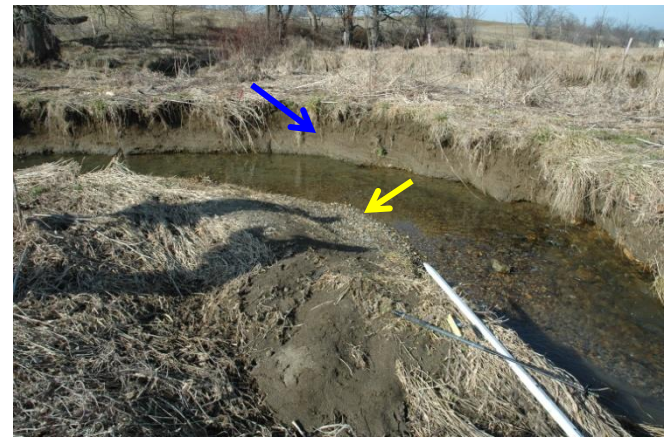
Figure 12. Photographs of the four different bank types. Upper Left: Type 1a, bank height is 1.1 m. Upper Right: Type 1b, bank height is 0.9 m. Lower Left: Type 2, bank height is approximately 1 m. Lower Right: Type 3 indicated by a yellow arrow. Type 1b indicated by a blue arrow. Stadia rod on Type 3 bank edge is extended 2 m.

Three bank types were identified and labeled as Types 1a, 1b, 2, and 3 (Figure 12). Type 1a banks contain >80-90% silt and clay and have vertical to near vertical bank faces that appear to be highly erodible. Sub-vertical fractures parallel to the bank face are common in this bank type. This bank type is common along the outside of meander bends. Type 1b is the same as Type 1a but has a higher content of sand and, locally, some gravel. In addition, Type 1b banks are slightly lower than Type 1a banks and younger in depositional age. They were deposited within the stream corridor since incision into the fine sediment that comprises bank Type 1a. Minor amounts of plastic and aluminum trash have been found in Type 1b banks. Type 2 banks are hummocky, typically vegetated with grasses, and most common along straight reaches of the BSR channel. In many places, the hummocky masses are slump blocks that are not yet completely disintegrated. Type 2 banks have irregular bank heights and evidence of both erosion and deposition, although neither is as notable as for Type 1a, 1b, and 3 banks. Type 3 banks are common along the inside of meander bends. Type 3 banks have higher sand and gravel content and more gently sloping banks (low bank angle) than all other bank types, with clear evidence of recent, ongoing deposition during moderate to high flow events.

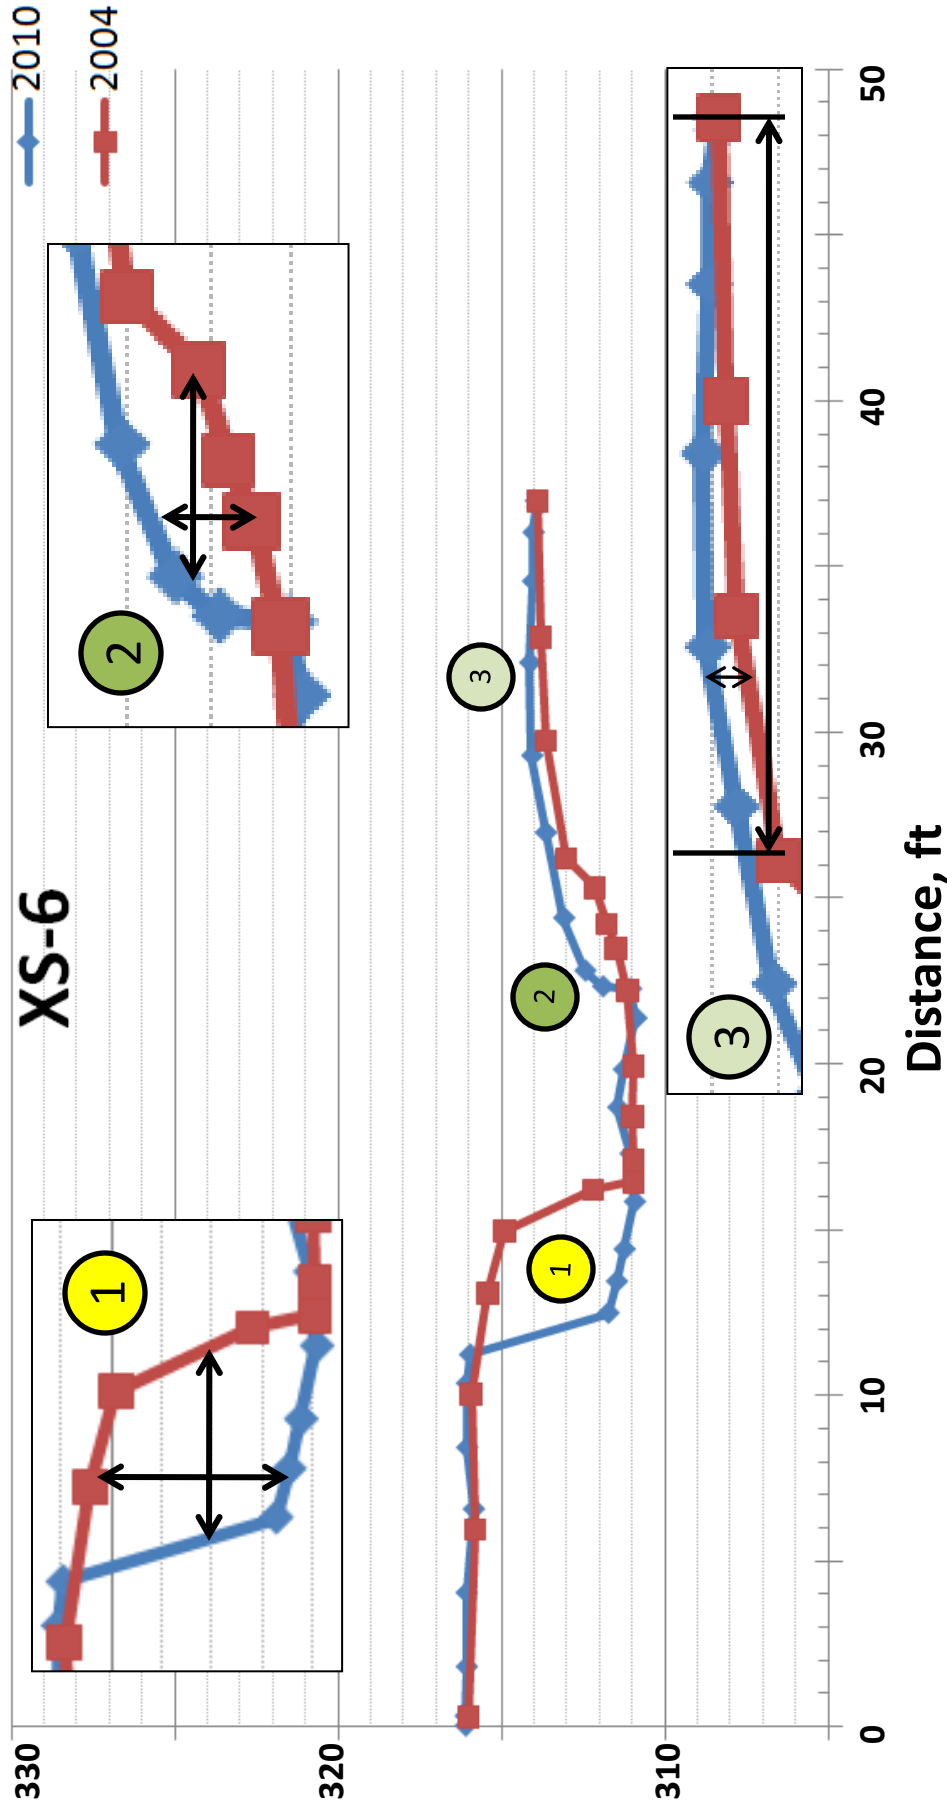
Fig. 13. Procedure for calculating area of erosion and deposition from repeat surveys of a stream channel cross section. In this example (cross section 6 at the "Type Locality"), left bank (as viewed downstream) is mapped as Type 1a and right bank as Type 3. In step (1), the average height (h) is measured and multiplied by the average width (w) to generate area. The area of deposition (2 and 3) is measured in the same manner. Deposition at the toe of the bank is shown as (2), and deposition at the top of the bank is shown as (3). For both erosion and deposition, the average area for all cross sections is calculated. This average value is multiplied by total bank length for the respective bank type in order to calculate volume of sediment eroded or deposited.

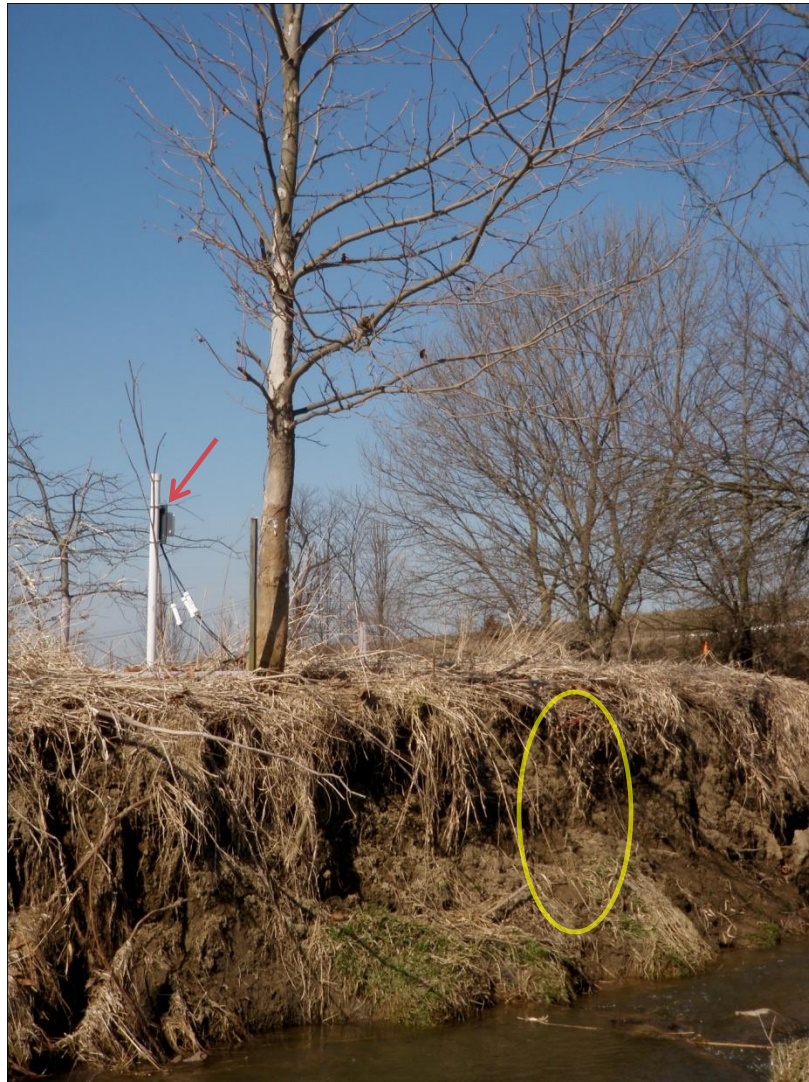
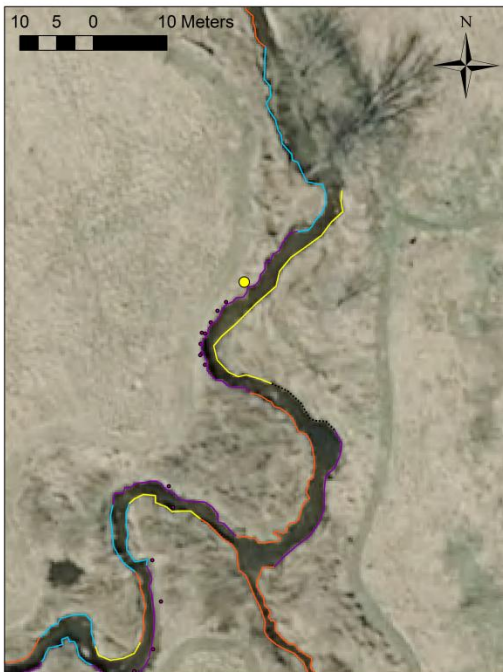
Figure 14. In the photo above the HOBO data logger is marked with a red arrow. It was placed high up on the bank to protect it from high flows and attached to a post to keep it safe. The sensors were placed at varying heights in the bank below, circled in yellow. The map to the left shows the location of the sensor (yellow dot) just north of the “Type Locality.”

examined for the presence of needle ice. The HOBO datalogger was attached to two soil temperature probes and two moisture content probes (Figure 14). One temperature sensor and a moisture content sensor were installed approximately 0.5 m above water level along the exposed east-facing stream bank at the “type locality”, and a second set of sensors was installed ~0.3 m above the first pair. The HOBO sensors and data logger were set to record information every three minutes. The instruments were installed in November, 2009, and the data downloaded and analyzed in early April, 2010.

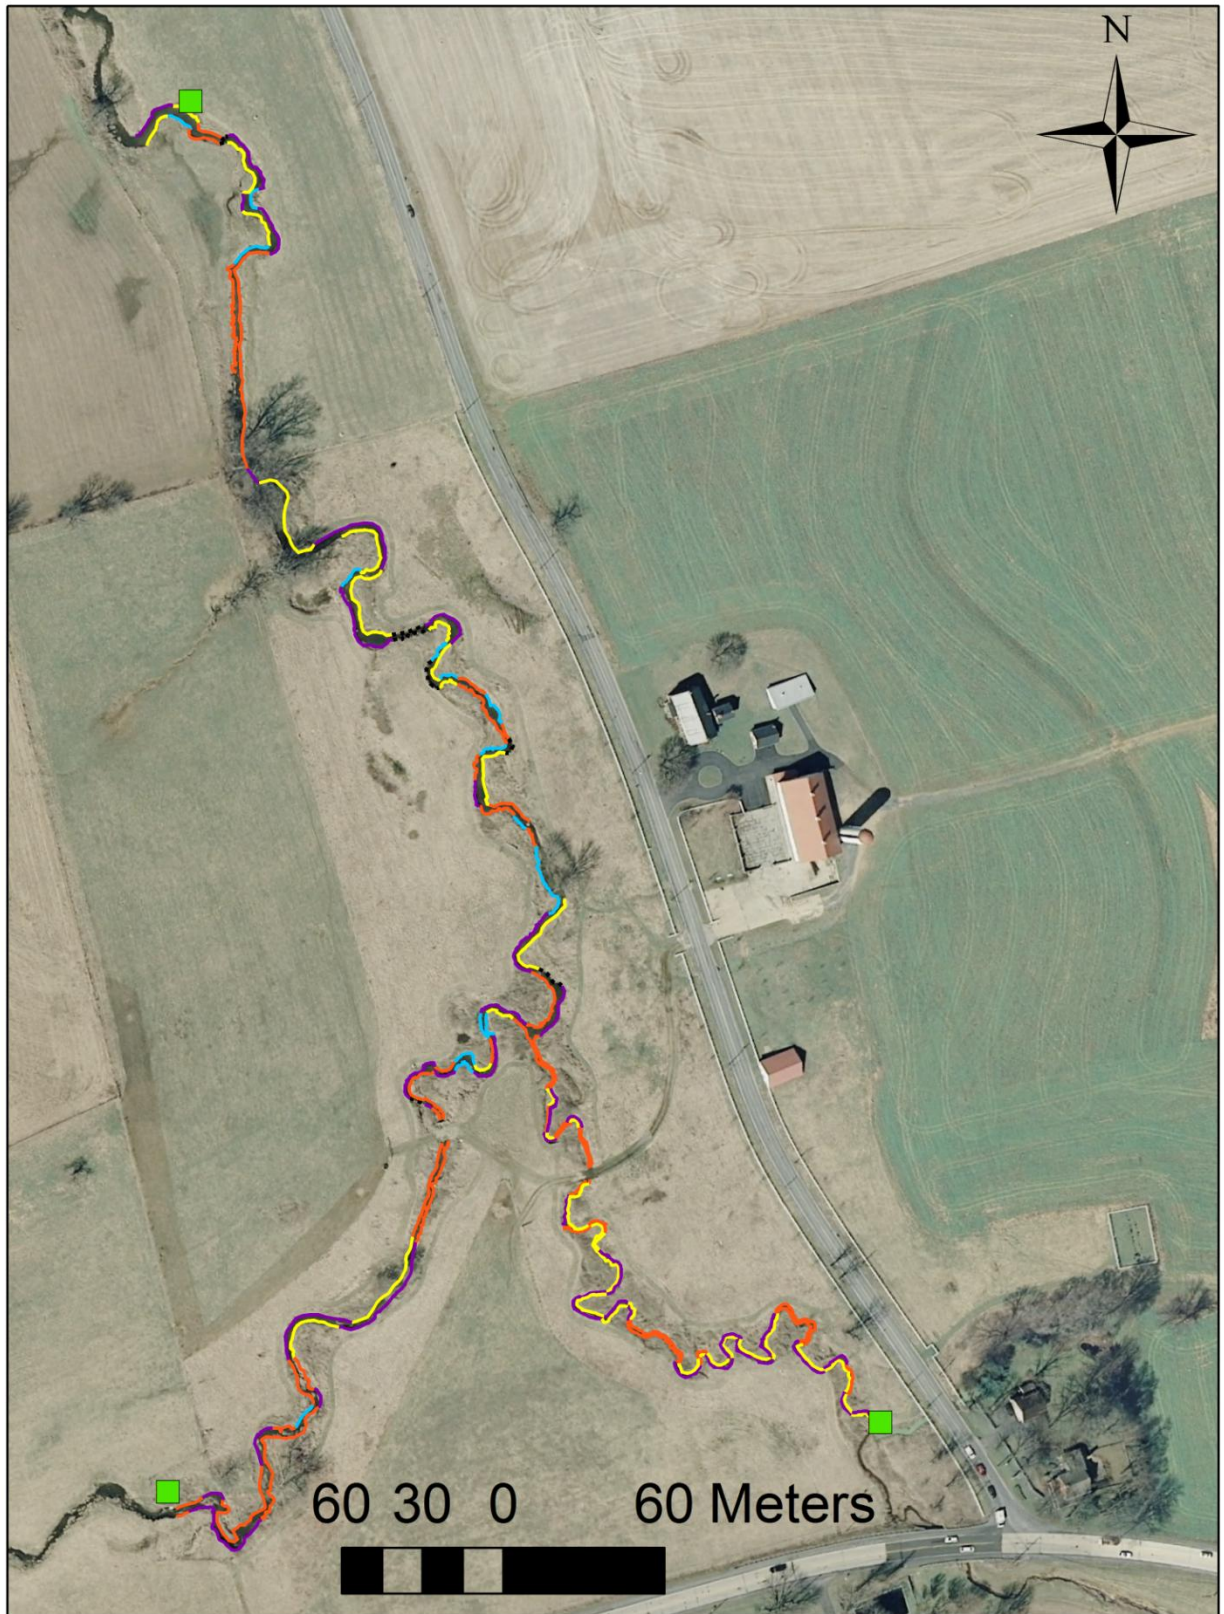
Figure 15. Digital orthoimage (2008) showing bank types. Purple represents Type 1a, blue Type 1b, orange Type 2, and yellow Type 3. Dashed black lines represent regions of rubble, originally laid down to protect a sewer line. Two segments of bank have been left uncolored. These banks are against the valley wall, which consists of colluvium and bedrock. The segments of bank downstream of the northernmost gage station have been mapped but were not included in the calculations.
