# Rates and processes of stream bank erosion and its contribution to suspended sediment load, Big Spring Run, PA

**Andrea Shilling**  
**Earth and Environment Department**  
**Franklin & Marshall College**

*Advisor: Dorothy Merritts, Earth and Environment*  
*Franklin & Marshall College*  
*GEO490: Independent Study*  
*Project Submission: May 7, 2009*  
*Graduation: May 15, 2010*

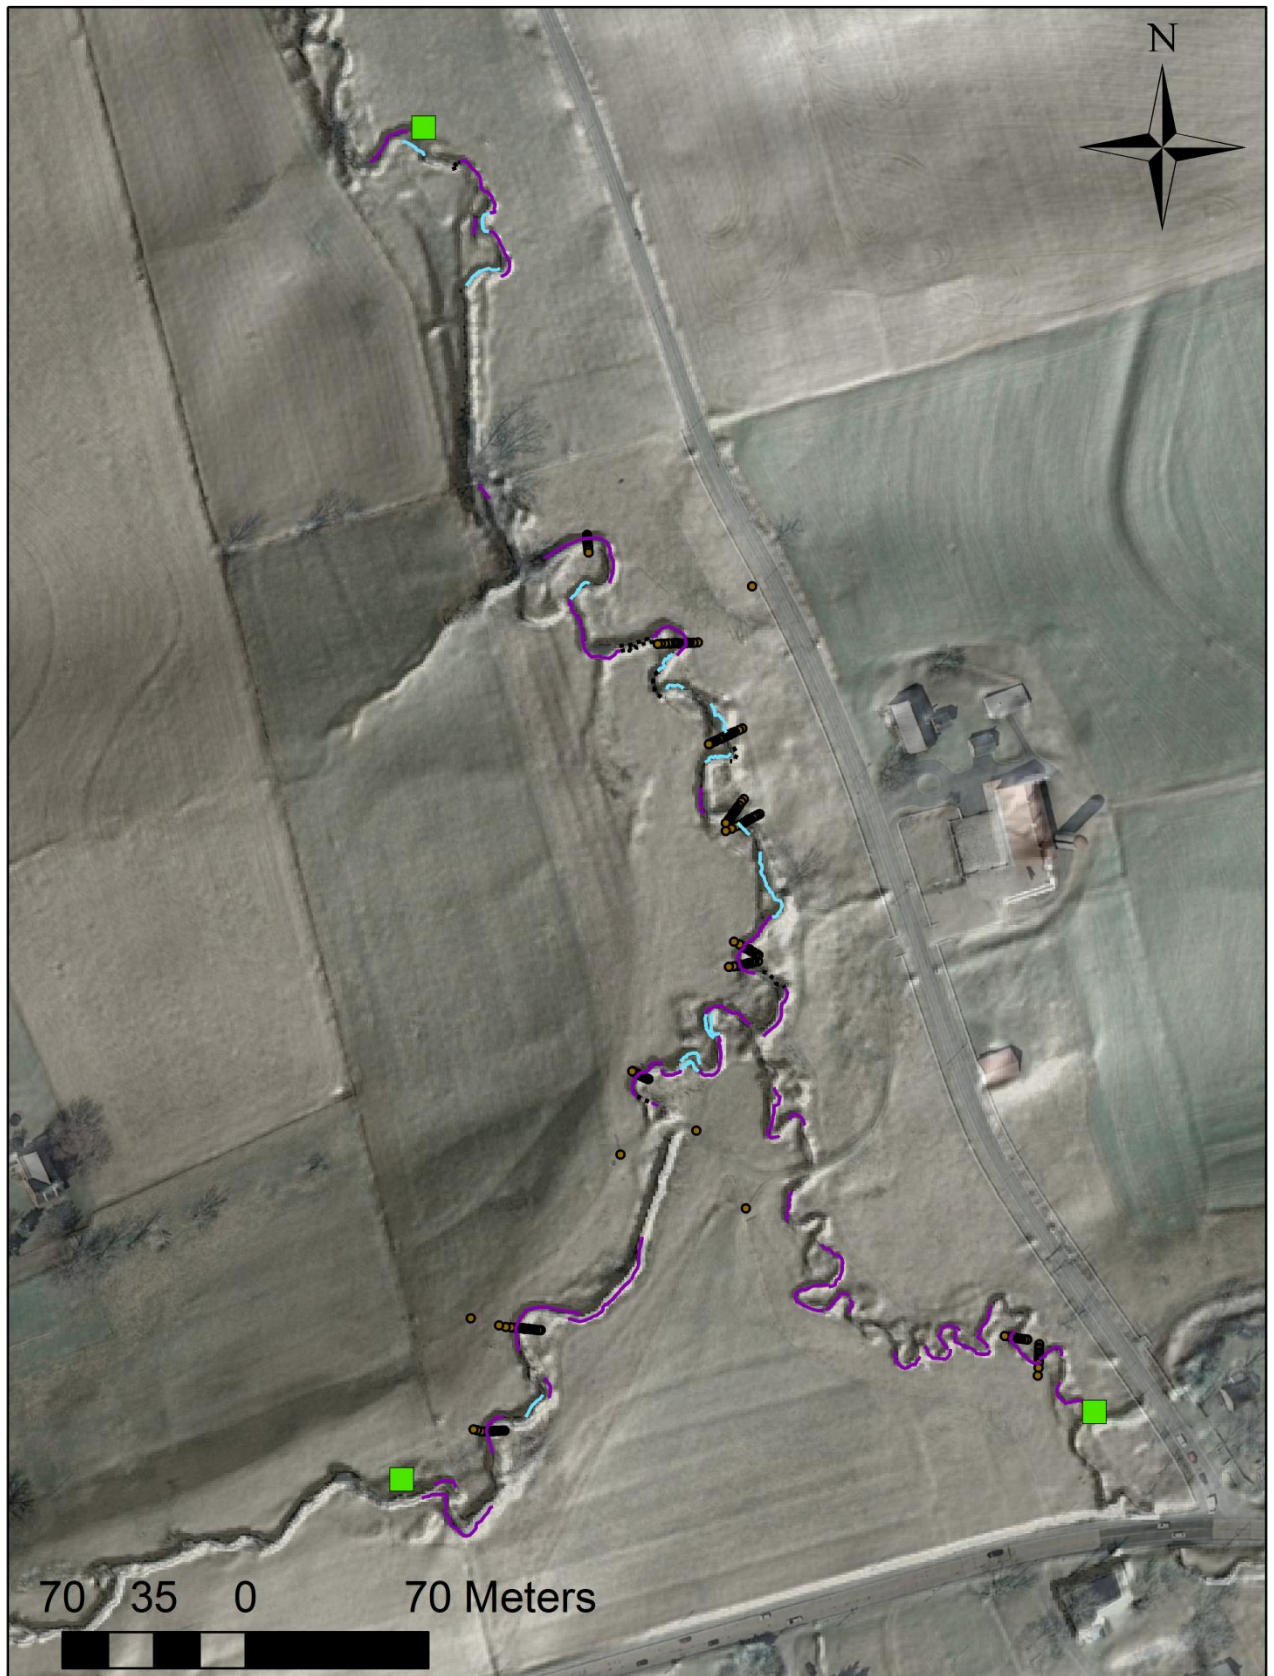
Figure 16. Lidar with 2008 digital orthophoto draped over top showing banks experiencing erosion (Type 1a in purple and Type 1b in blue). Total distance of Type 1a and 1b is 952 m.

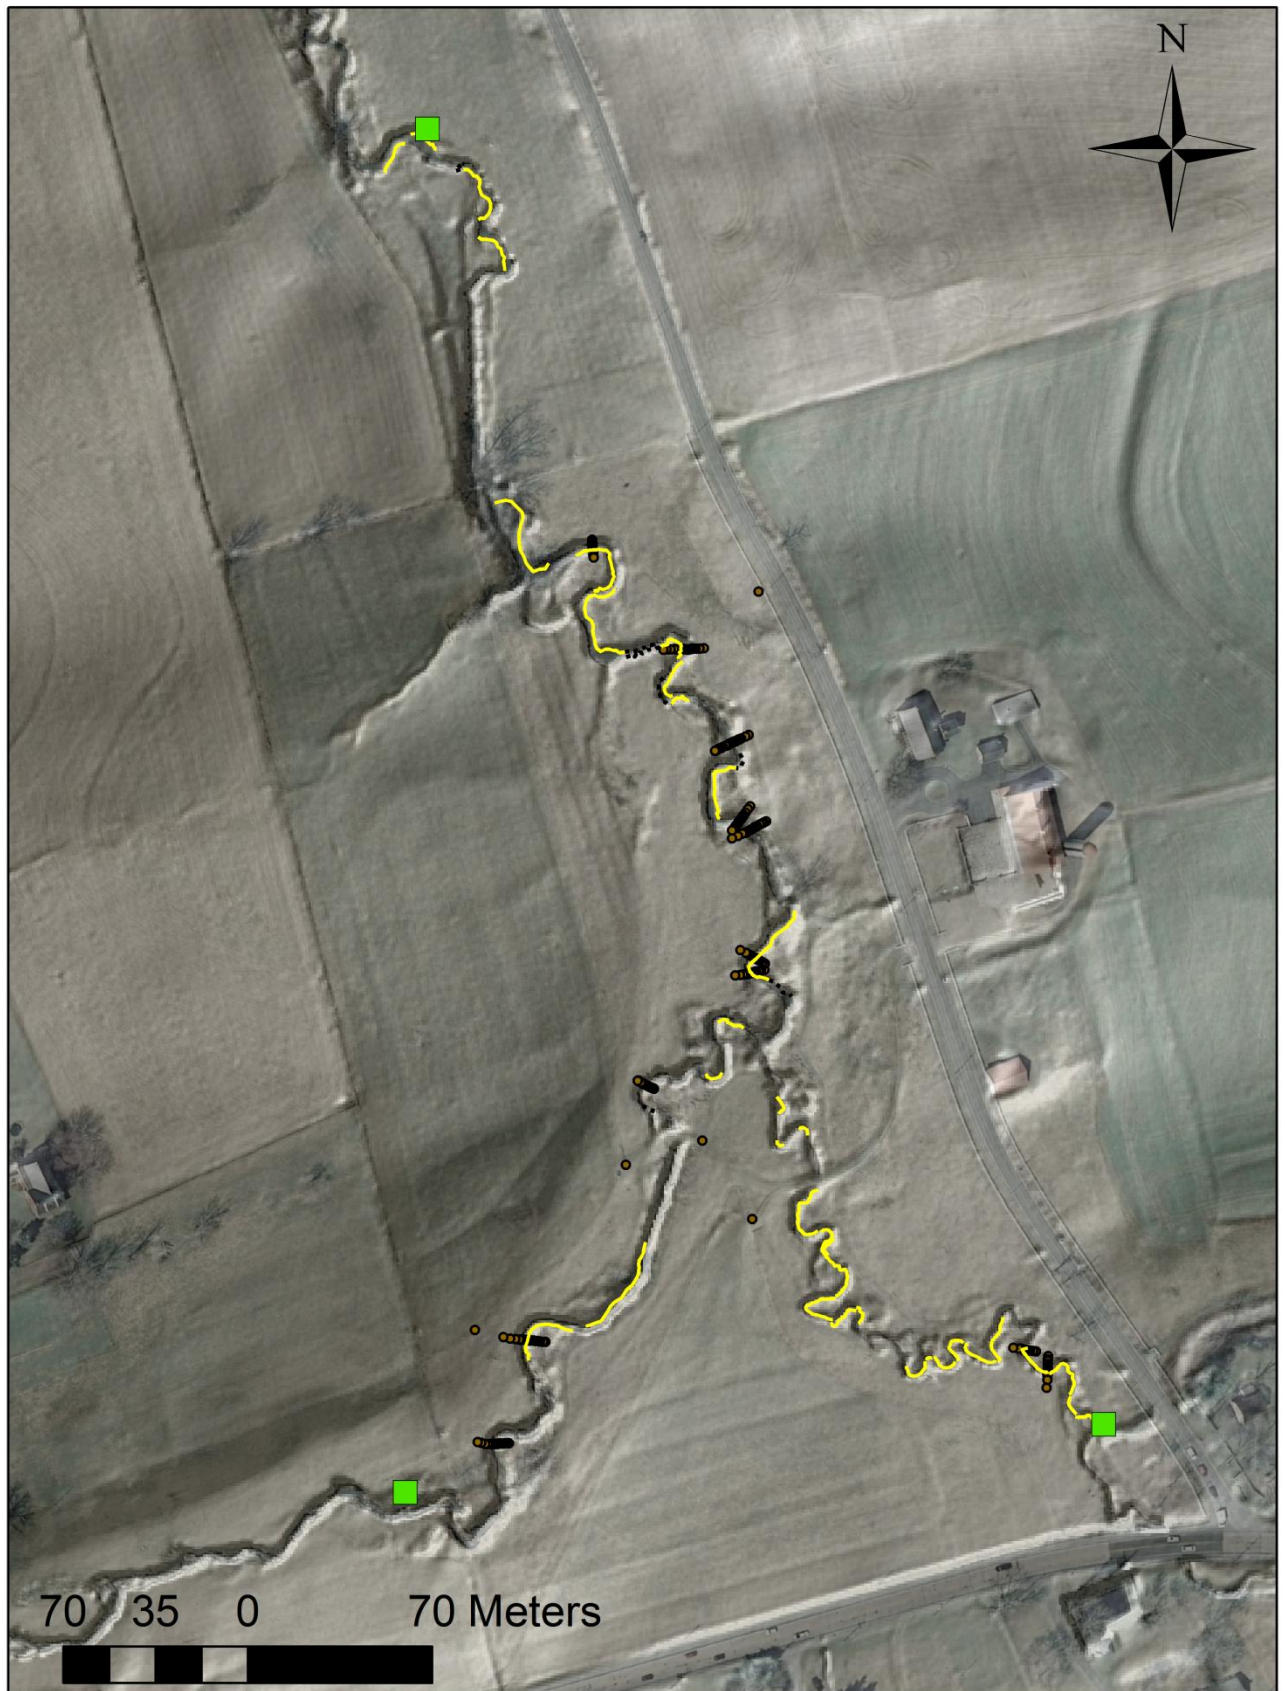
Figure 17. Lidar image with 2008 digital orthophoto draped over top showing banks experiencing deposition, Type 3 shown in yellow. Total distance of Type 3 banks 671 m.

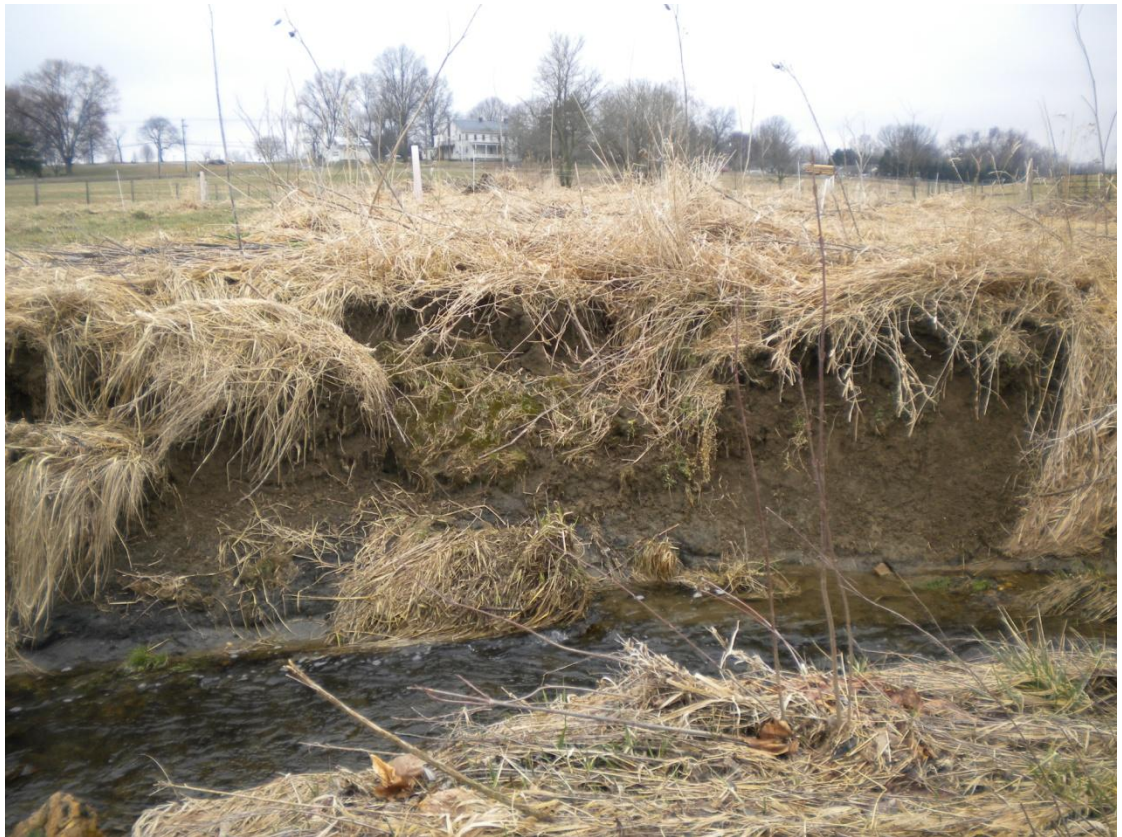
Figure 18. (Above) Image showing mass movement erosion of a bank along BSR.

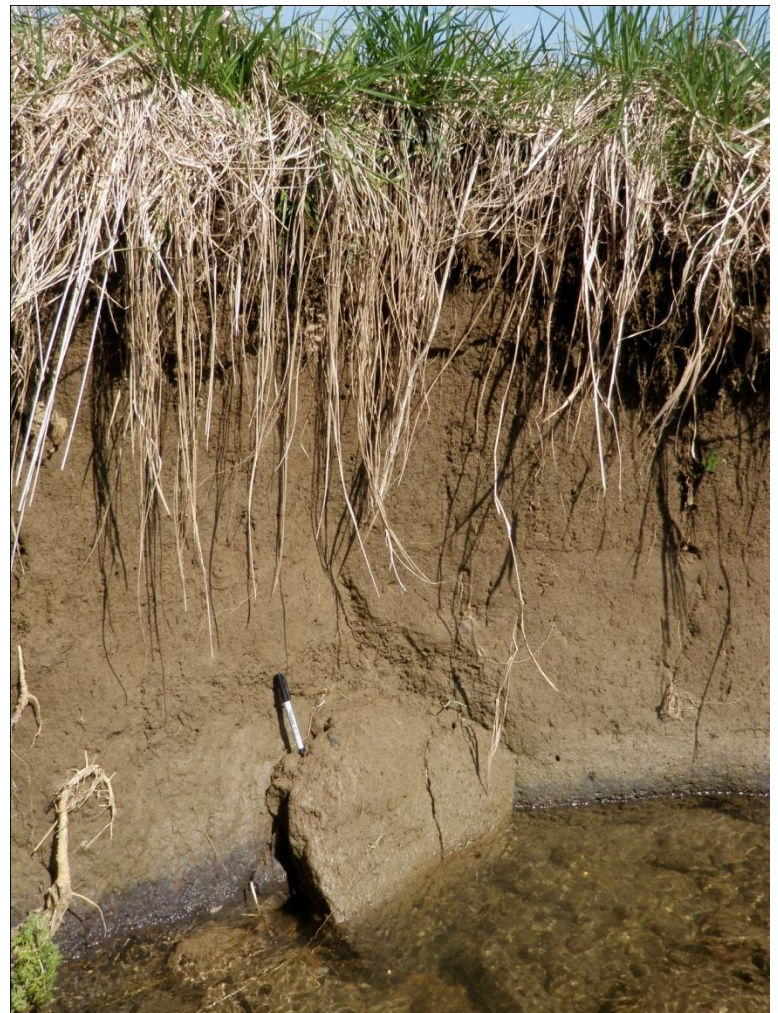
Figure 19. (Right) Image showing mass movement on a smaller scale, only part of the bank has collapsed.

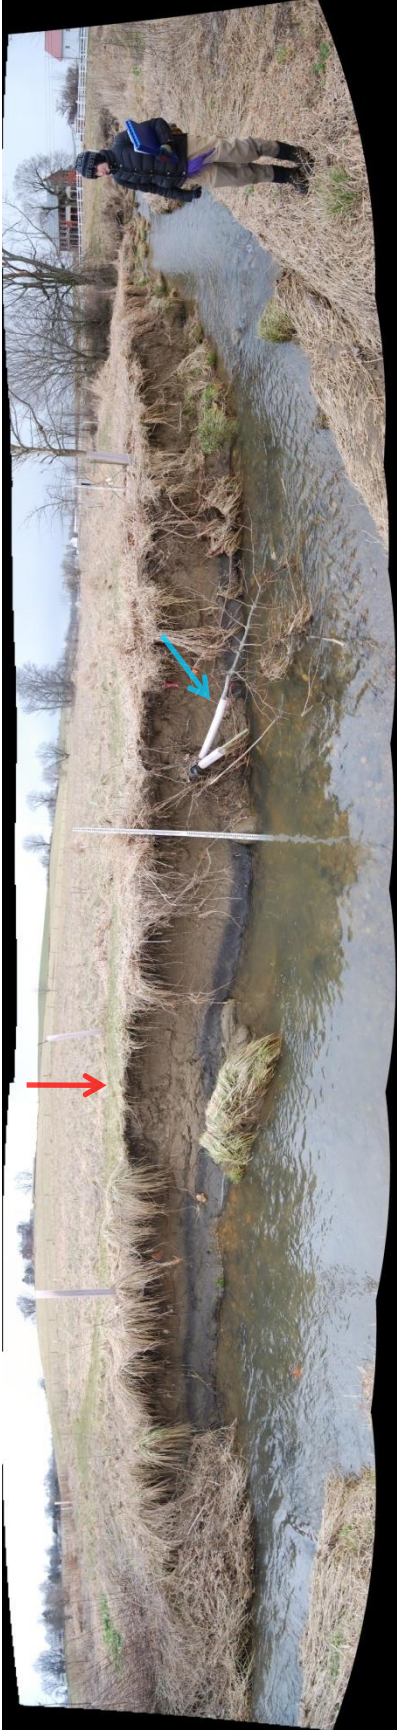
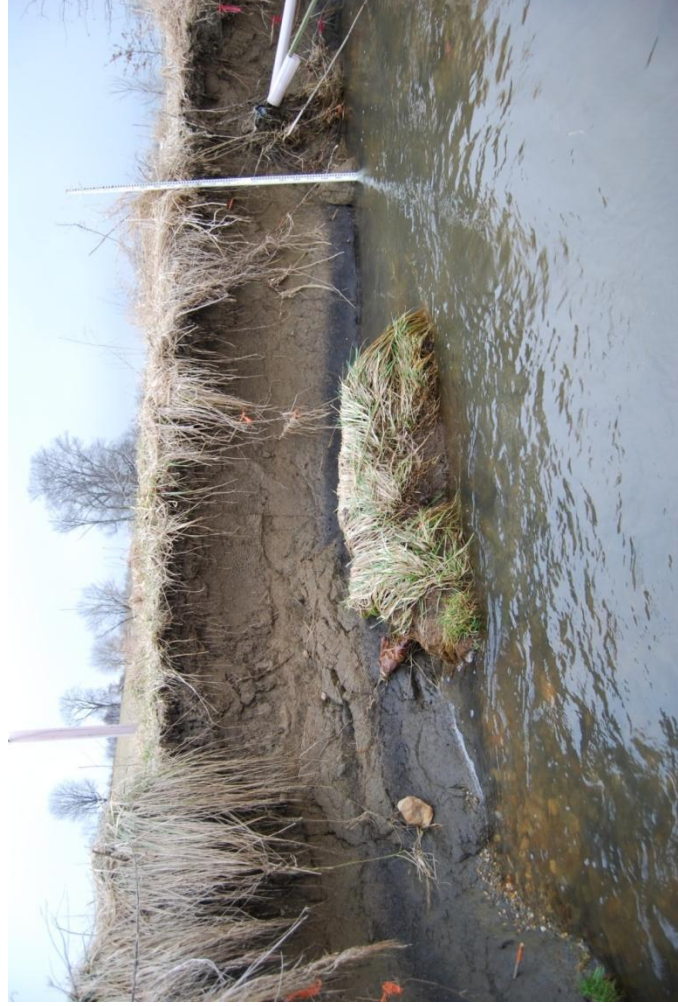
Figure 20. Panorama photo showing the “Type Locality” after mass movement erosion. After an especially high flow even a large slump block fell into the stream as well as a tree which collapsed into the stream. The slump block is shown in an enlarged photo so that additional details of the mass movement can be seen. A red arrow in the panoramic photo indicates where the slump block was before it fell into the stream. The fallen tree is identified by a blue arrow.

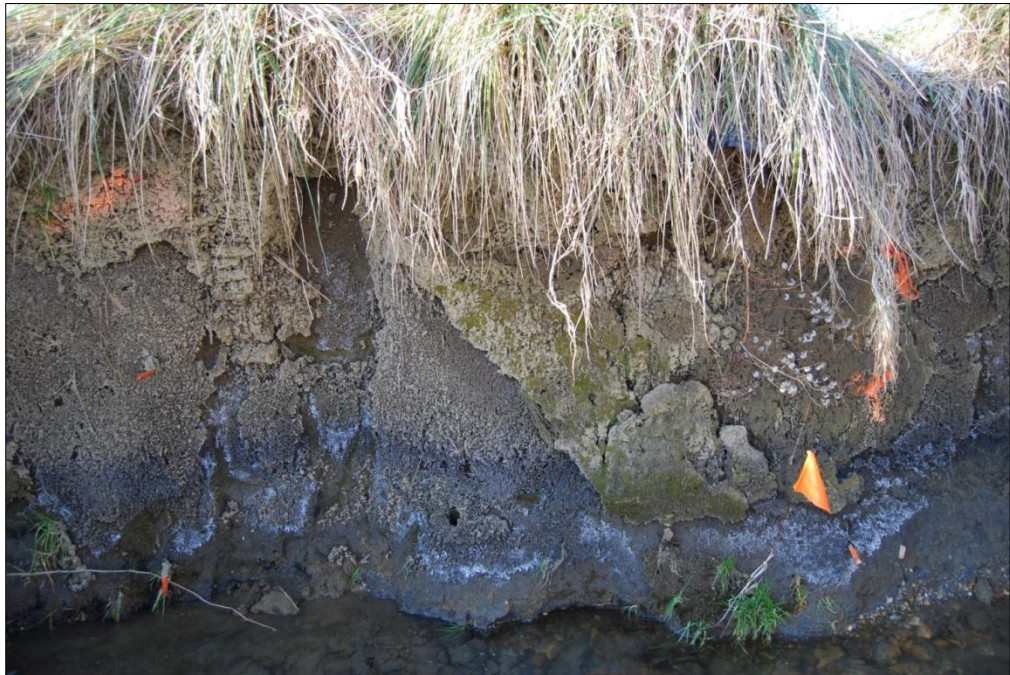
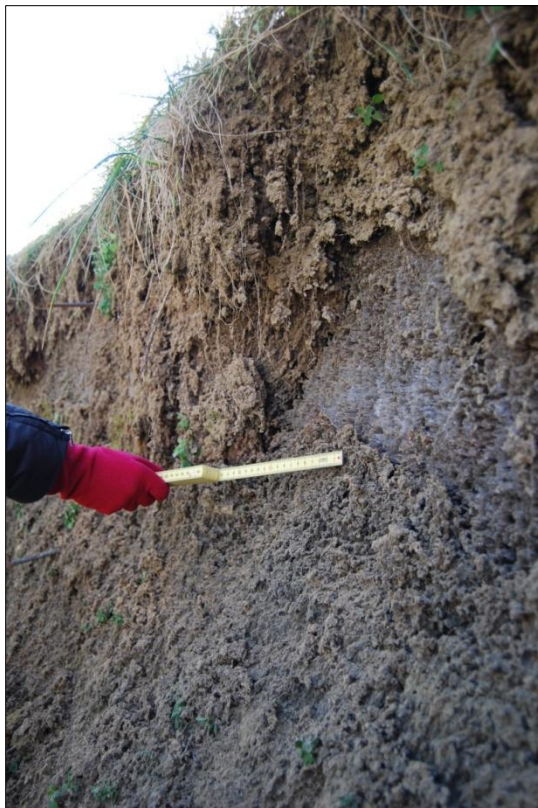
Figure 21. (Above) image (taken 12/17/09) of a Type 1a bank showing needle ice formation and the layer of sediment pushed out ahead of the needle ice. Areas of sediment that have fallen into the water recently are obvious by the absence of moss. (Left) Image from the same day showing an apron of sediment collecting at the base of the bank below the needle ice.

primary mechanisms of needle ice erosion were discussed earlier (see Figure 9). At several sites and during multiple visits, needle ice was observed pushing sediment outward from the bank. As seen in Figure 21, some of the sediment fell from the bank face directly into the water. In this way, needle ice acts as a primary source of erosion. Needle ice acts as a secondary means of erosion when it loosens sediments and prepares it for subsequent erosion.

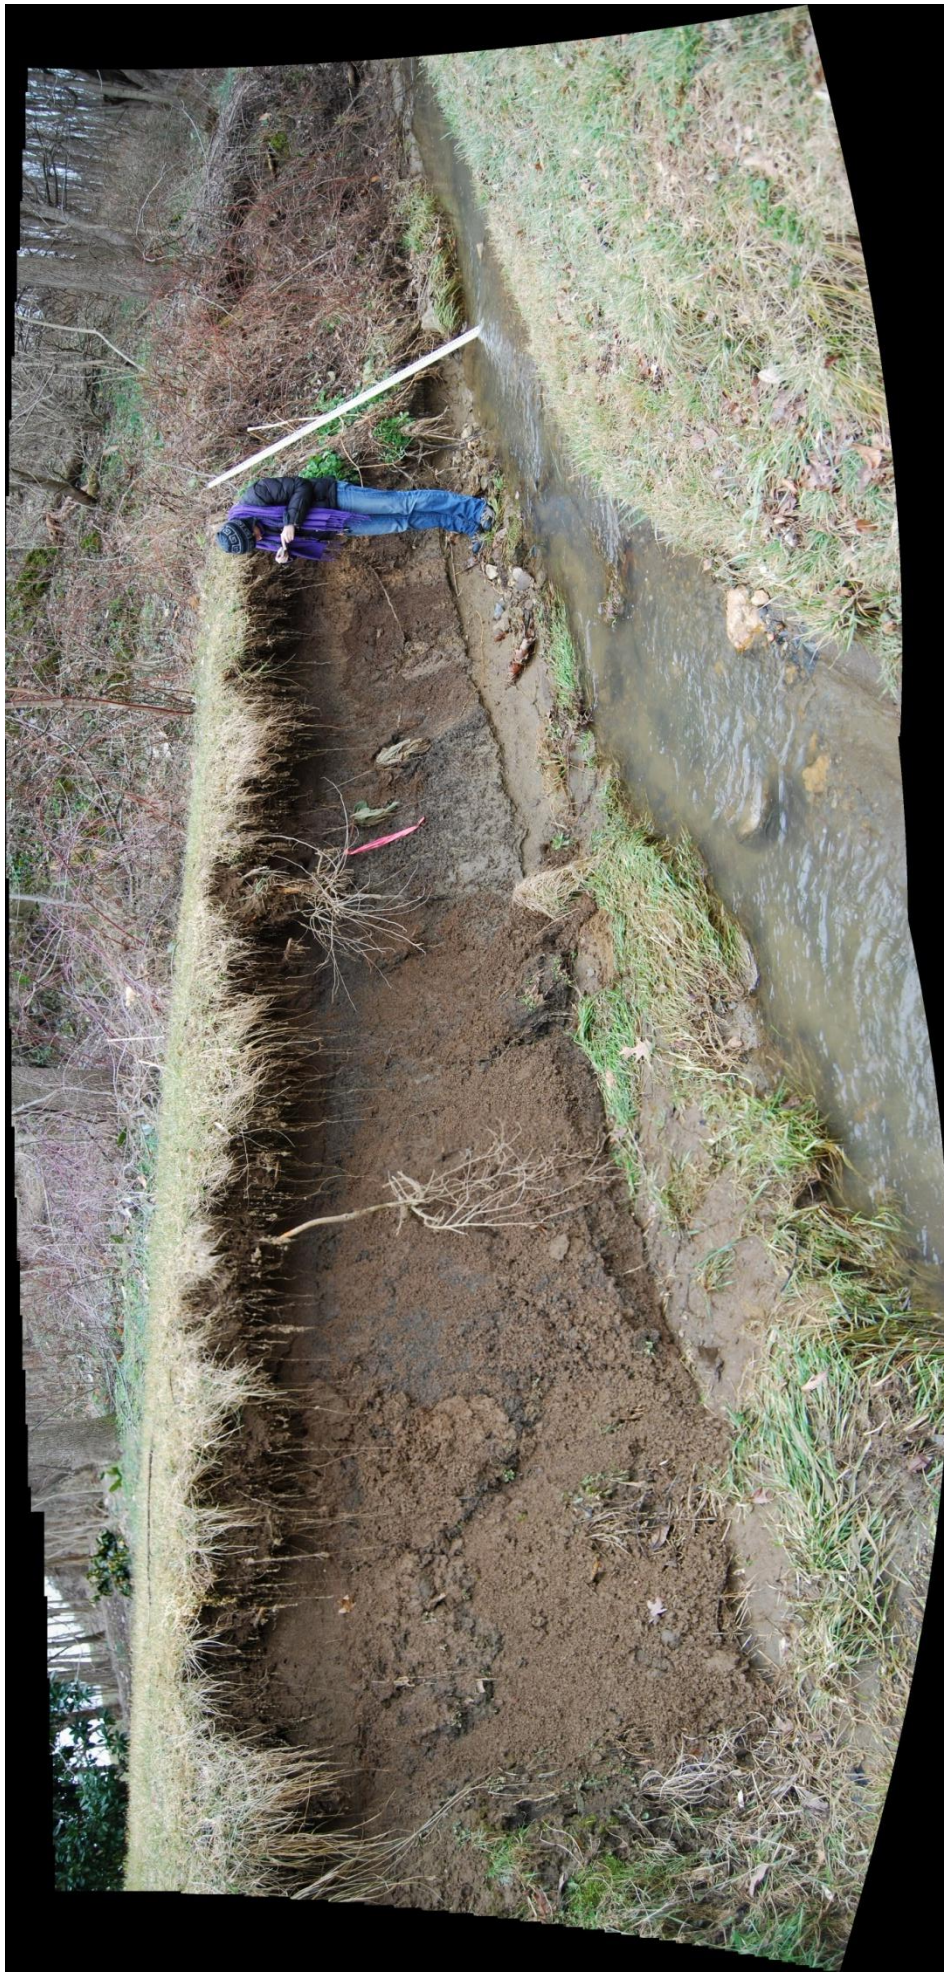
Figure 22. Image showing both the formation of an apron of sediment at the base of the bank due to needle ice and the formation of a notch fluvial entrainment removed sediment from the base of the apron during a high flow event. Location of site is eastern tributary ( UTM coordinates 392857.867, 4427237.289).

While numerous examples of this process of secondary subaerial erosion were observed, the bank face shown in Figure 22 illustrates this process particularly well. Not only can the apron of sediment produced by the needle ice be seen, but also it is evident that some of the sediment was removed from the base of the apron in a recent high flow event. This removal of sediment by water flow is evidence of fluvial entrainment.

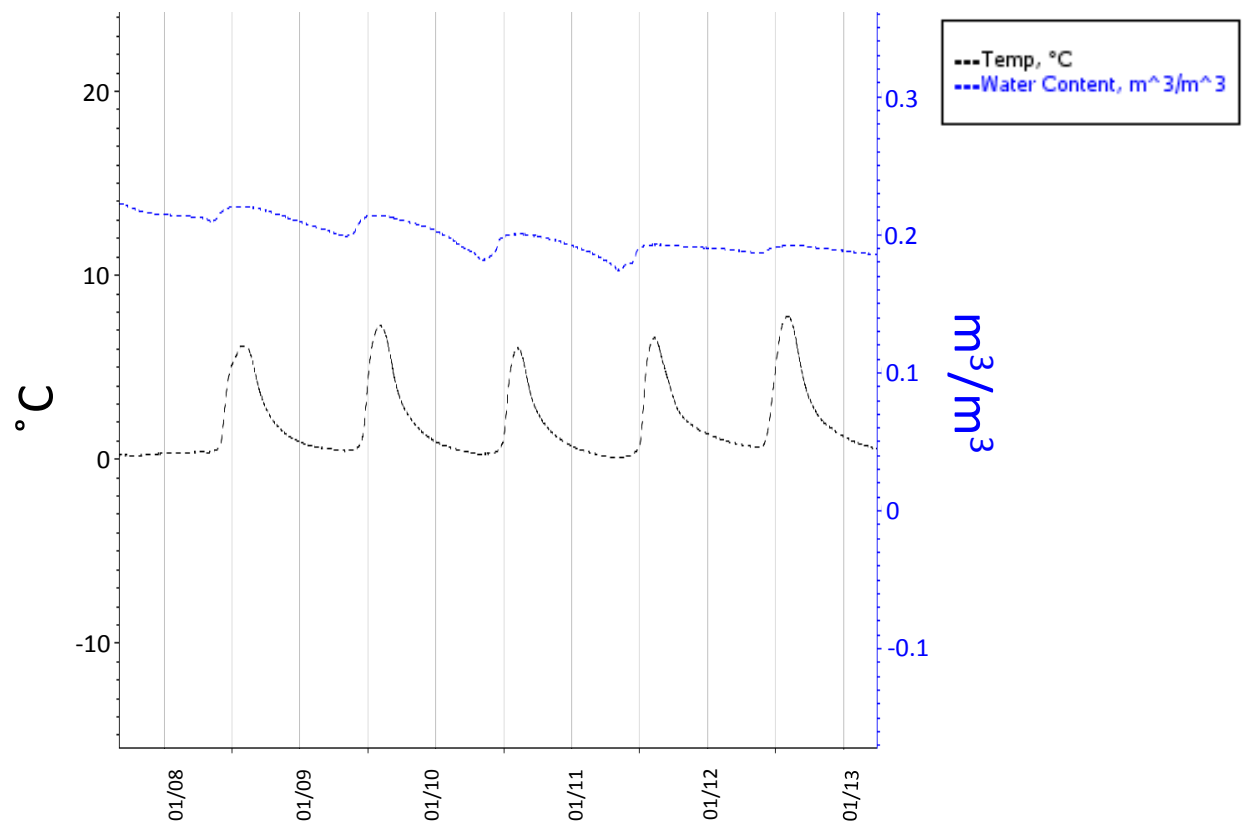
Figure 23. Five freeze-thaw events detected with two HOBO sensors placed in the stream bank at “Type Locality”. Water content decreases with the lowering of temperature and formation of ice in the pore spaces of the bank sediment.

Aside from visual observations of needle ice, evidence of freeze-thaw events was detected with the two HOBO sensors that monitored the temperature and moisture content of the east-facing bank face at the “Type Locality”. A similar method was used by Wynn et al (2008) to detect freeze thaw events from temperature and soil moisture content. According to Wynn et al (2008), a temperature decrease that is accompanied by a sudden decrease in moisture content is a sign of a freeze-thaw event. As moisture in the sediment freezes, it no longer is detected by the sensor, so the moisture content drops. Sensor data from a 5-day period from January 8 to 13, 2010, exhibits several freeze thaw events (Figure 23). Note that as temperature drops, so does the moisture content of the bank (compare to Figure 5 in Wynn et al, 2008).

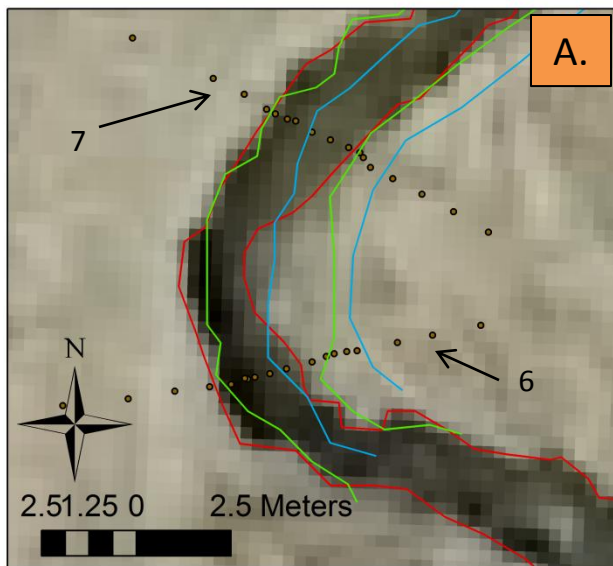
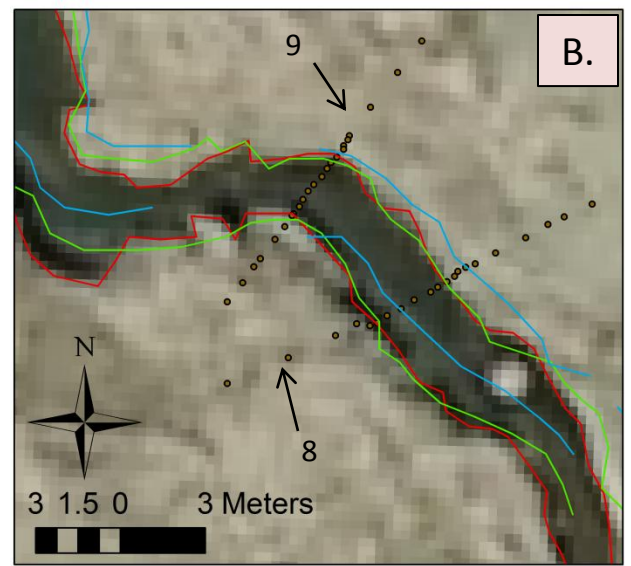
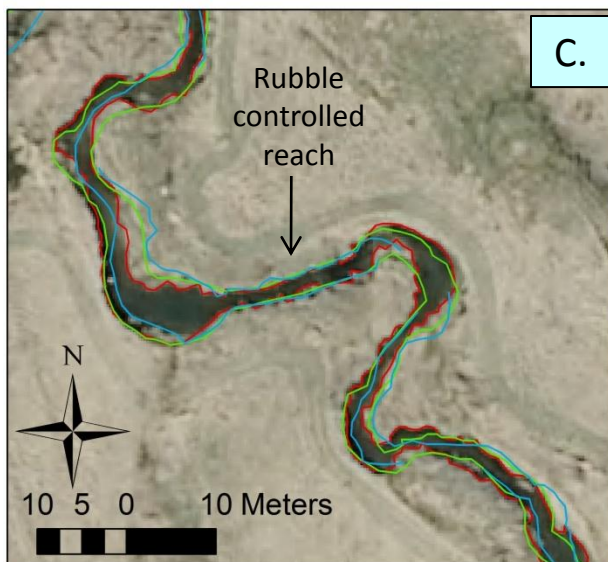
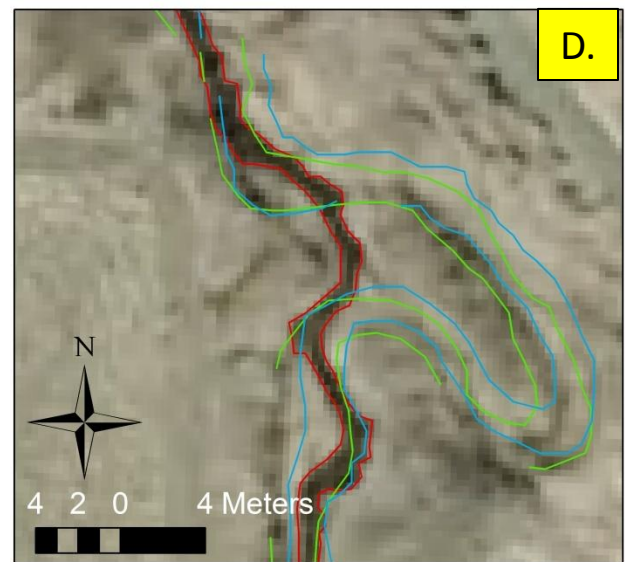
Figure 24. Four different views of BSR showing bank advance and retreat over 7 years. The blue lines represents the banks in 2001, green in 2005 and red in 2008. A.) "Type locality" with cross sections 6 and 7. B.) Cross sections 8 and 9. C.) Reach of BSR with rubble along banks, showing little channel movement during the 7 years. D.) A meander bend had cut off between 2005 and 2008. Map to the right shows the location of A, B, C and D (the four images above) using color coordinated dots along BSR. The color of the dots match the colors of the boxes with the letters for each image.

Examples of bank erosion observed by tracing bank edges on digital orthoimages from 2001, 2005, and 2008 are shown in Figure 24. Aerial photographs of BSR taken with a remotely controlled airplane in 2006 also were used to visually assess the amount of bank retreat over 4 years (Figure 25). These aerial photographs support observations of erosion along bank edges as mapped on digital orthophotos from 2001, 2005, and 2008. Figure 26 is an aerial photograph taken in 2006 of a meander bend of BSR that was eroded as shown in Image D of Figure 24. Table 5 summarizes the type of bank at each erosion pin site, the identification number for each site (corresponding to the maps in Figures 8 and 9), the average annual erosion rate for each site (three to four pins per site, at top, middle, and bottom of bank), and the average annual erosion rate for all pins representing each bank type.

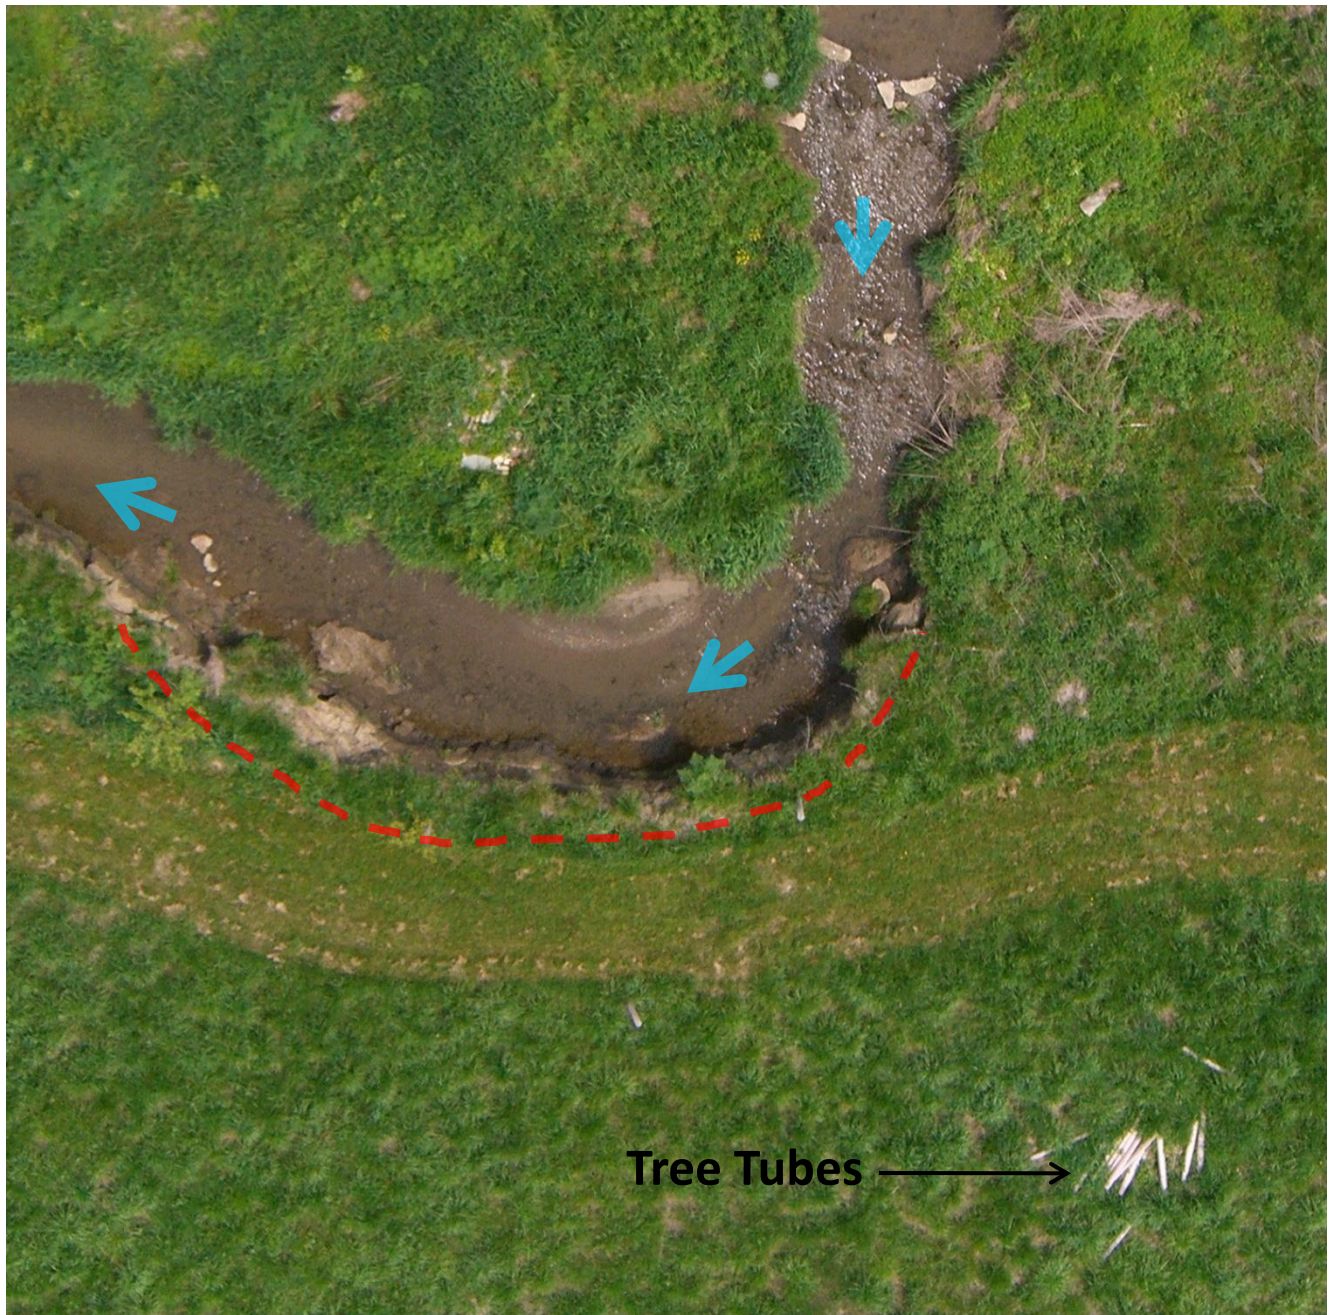
Figure 25. Aerial photograph of “Type Locality” in May, 2007. Dashed red line shows approximately where the bank is at present. Blue arrows designate water flow direction. Tree tubes are approximately 0.6 meters in length.

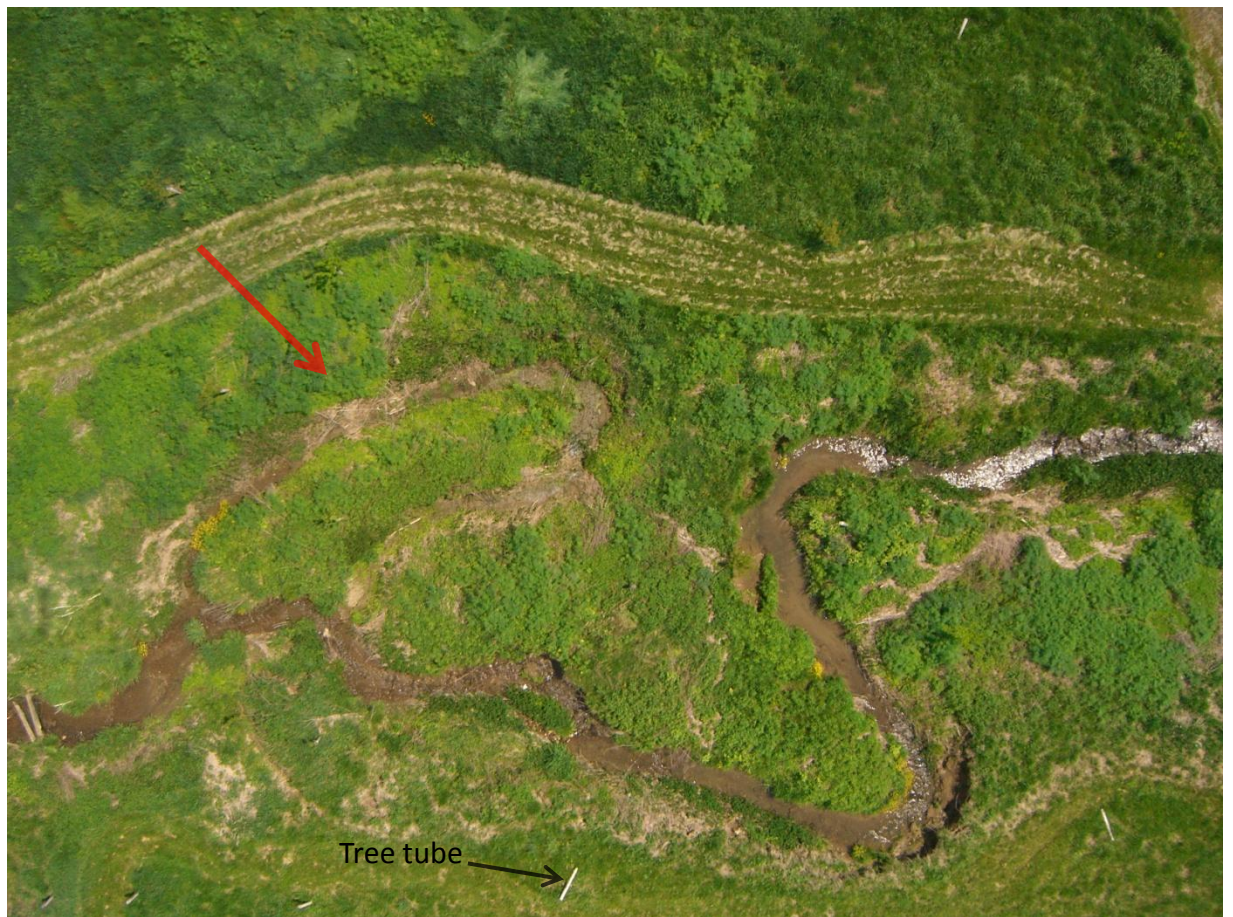
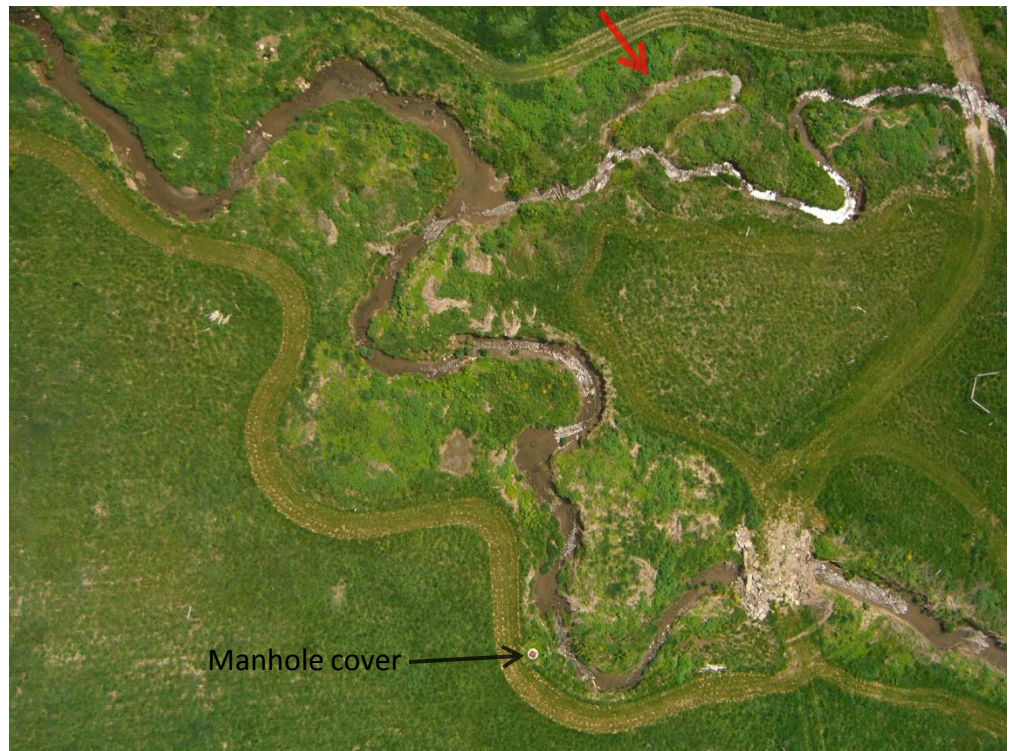
Figure 26. Aerial photos taken in 2007 showing and abandoned bend in BSR that was cut off between 2005 and 2008 as shown on image D in Figure 24. Red arrow points to the abandoned bend in each photo. Tree tubes are approximately 0.6 m in length. The manhole cover is approximately 0.7 m in diameter.

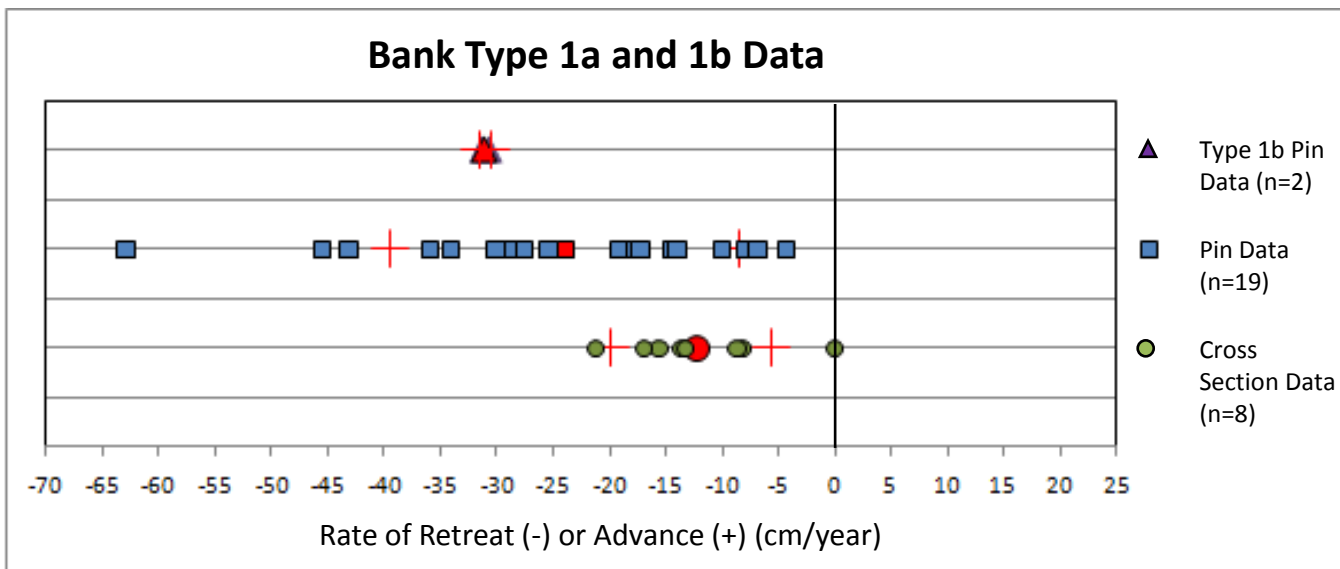
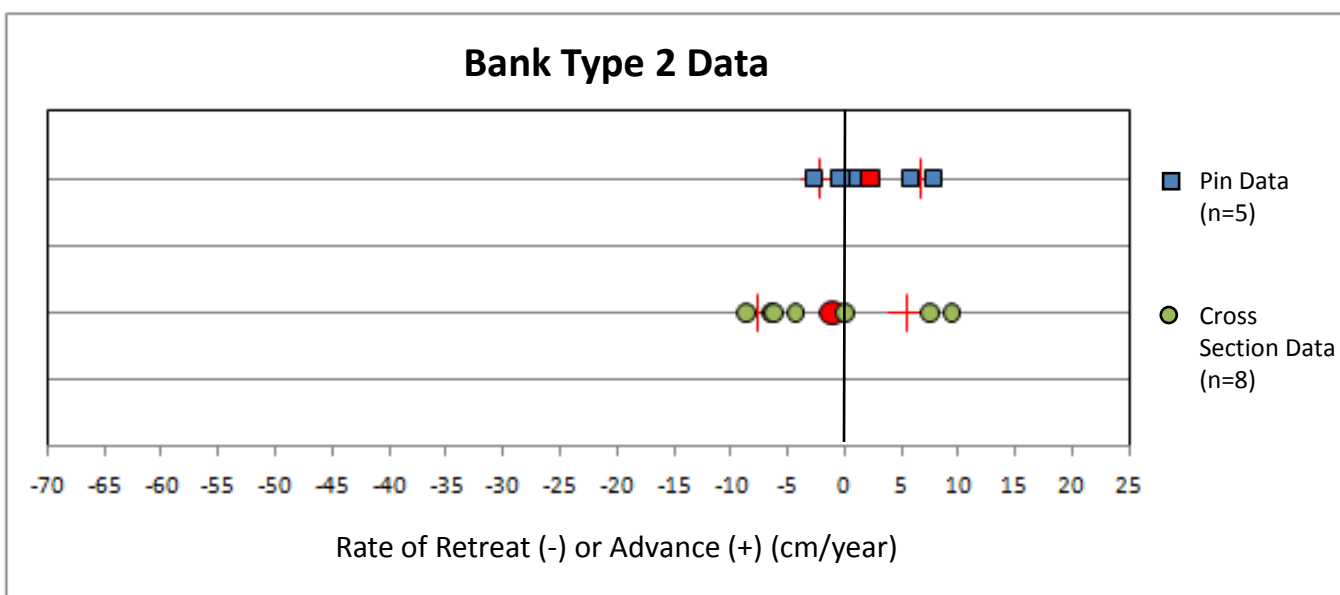
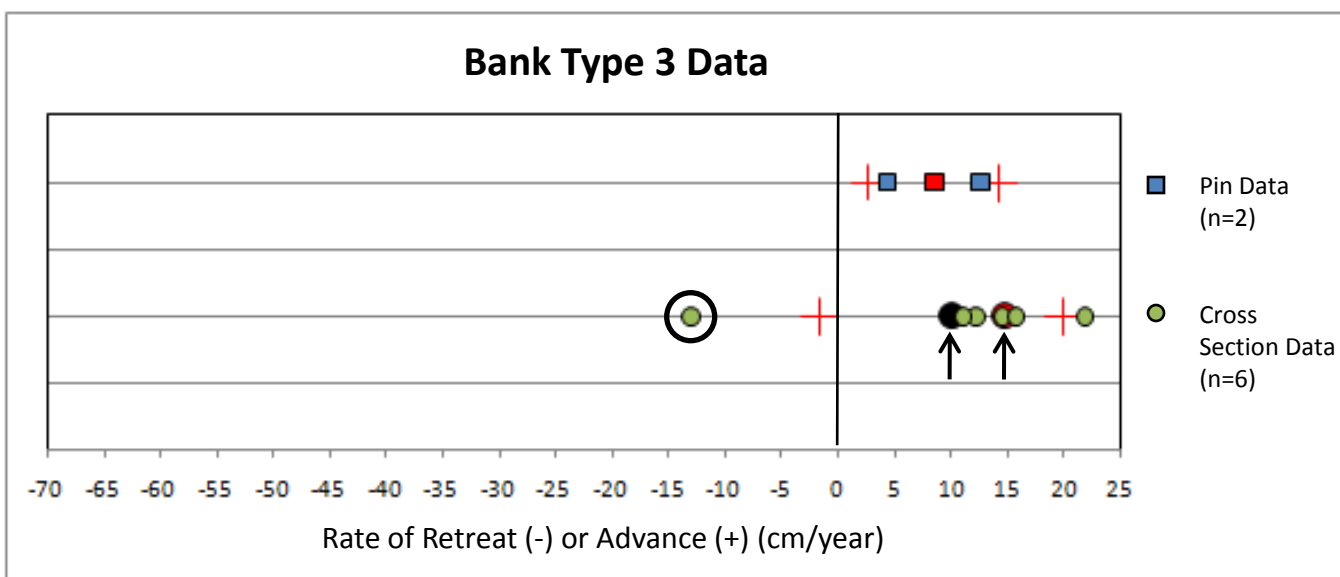
Figure 27. Series of graphs showing both the pin and cross section data for a given bank type. Pin data collected over 1-2 years. Cross section data was collected over 6 years. Red data point represents the average for that series. Red lines show  $\pm 1$  standard deviation for each series. Two averages for Cross Section Data shown with arrows in bottom graph. Arrow to the right shows the average without the circled outlier, arrow to the left shows the average with all values included.

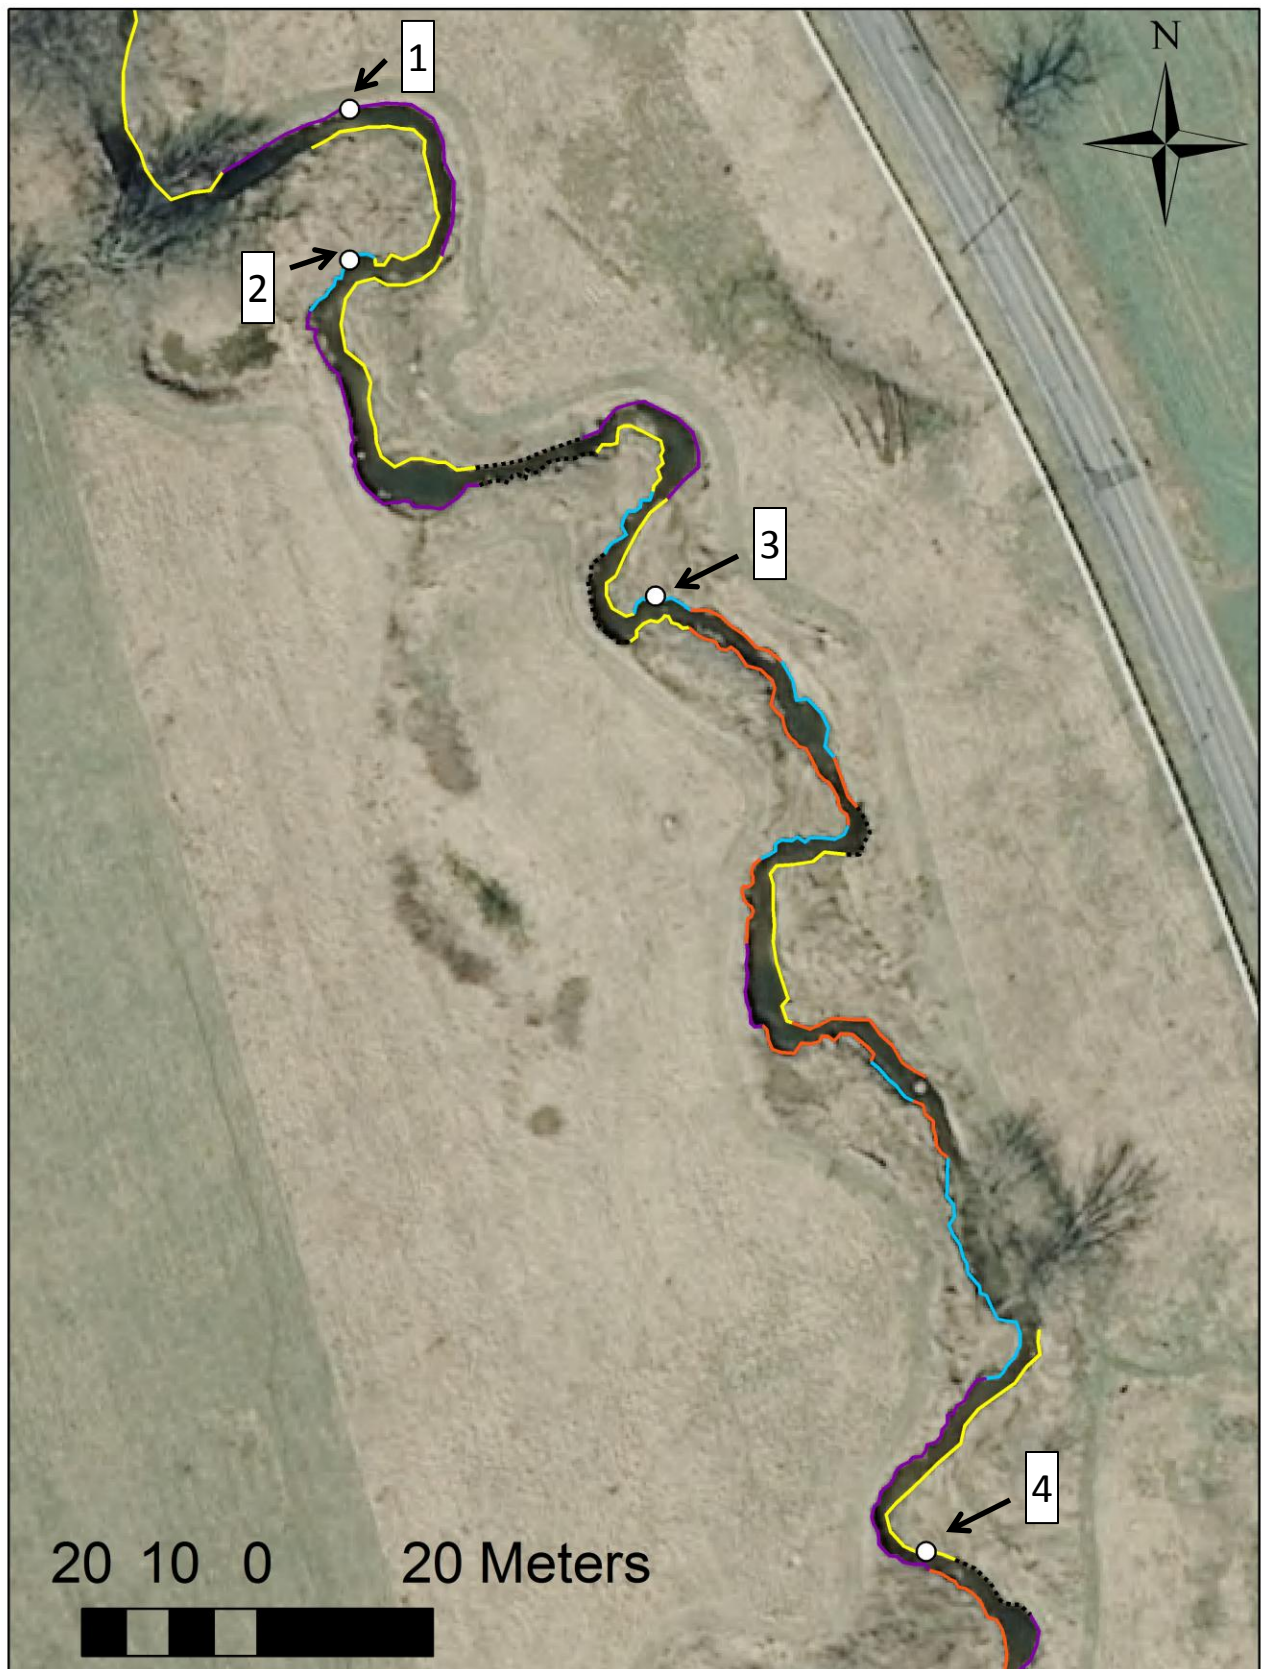
Figure 28. Map showing the sediment sample collection sites. Site 1, in bank Type 1a (purple) was collected and analyzed by Zach Stein in 2007, Sites 2 and 3, both in bank Type 1b (blue), were collected by Dr. Merritts and Dr. Walter and analyzed by Laura Kratz in 2010. Site 4, in bank Type 3 (yellow) was collected by Dr. Merritts and Dr. Walter in 2010 and analyzed by Laura Kratz.
