# Rates and processes of stream bank erosion and its contribution to suspended sediment load, Big Spring Run, PA

**Andrea Shilling**  
**Earth and Environment Department**  
**Franklin & Marshall College**

*Advisor: Dorothy Merritts, Earth and Environment*  
*Franklin & Marshall College*  
*GEO490: Independent Study*  
*Project Submission: May 7, 2009*  
*Graduation: May 15, 2010*

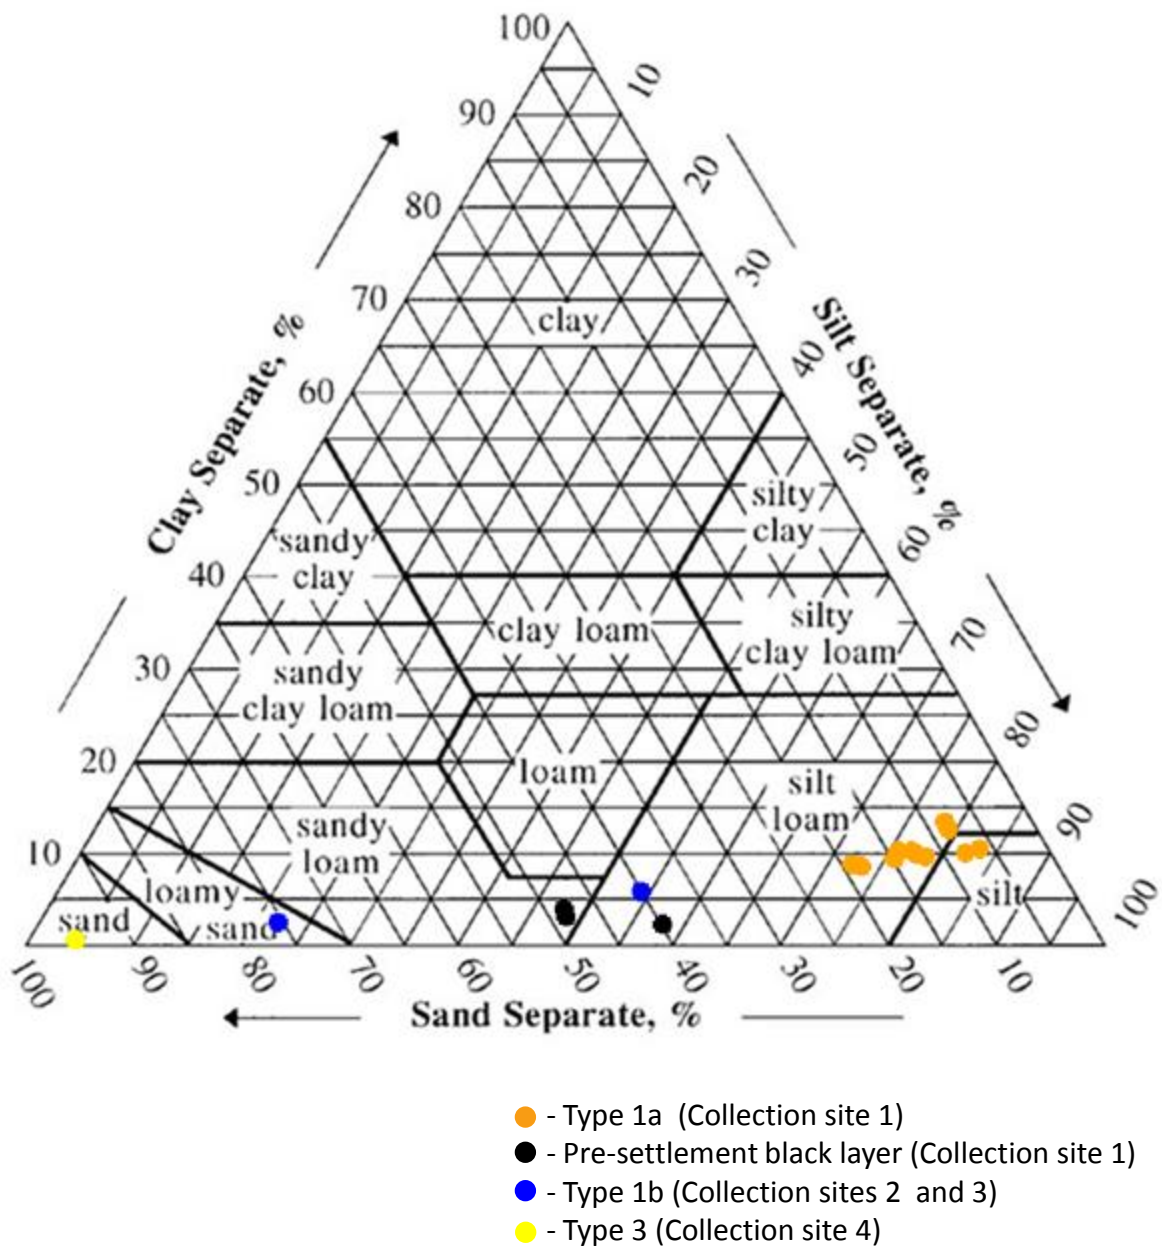
Figure 29. Ternary soil texture diagram for percent sand, silt, and clay by mass.

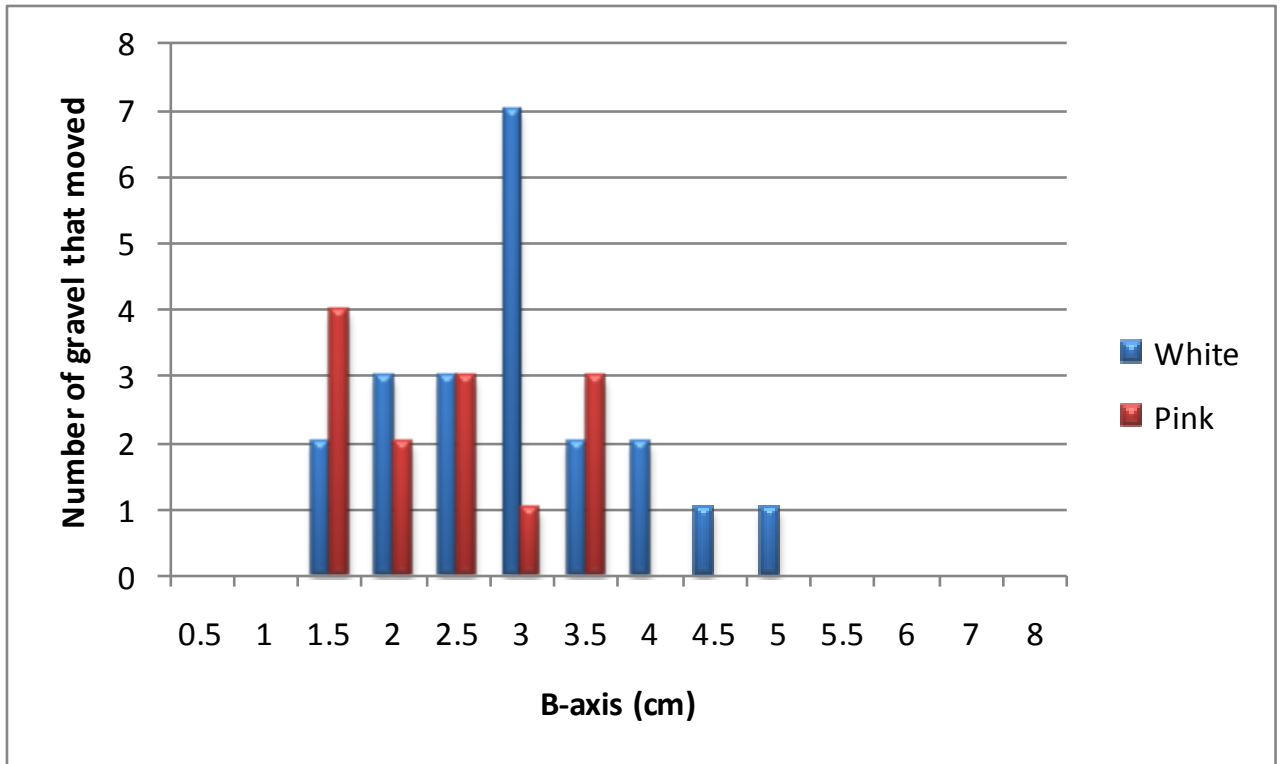
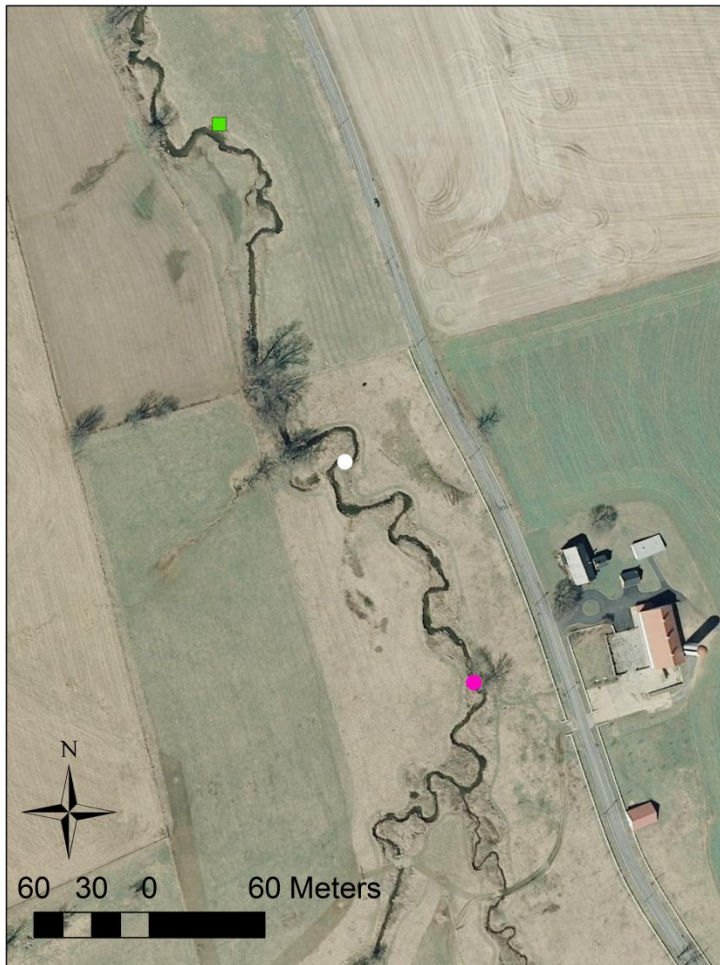
Figure 30. (Above) Size and number of gravel clasts that moved during high flow events between September and December, 2010. (Left) Map showing the location of gravel test sites. Pink dot corresponds with pink gravel, while dot corresponds with white gravel. Green square shows the downstream gauge station on the main stem of BSR.

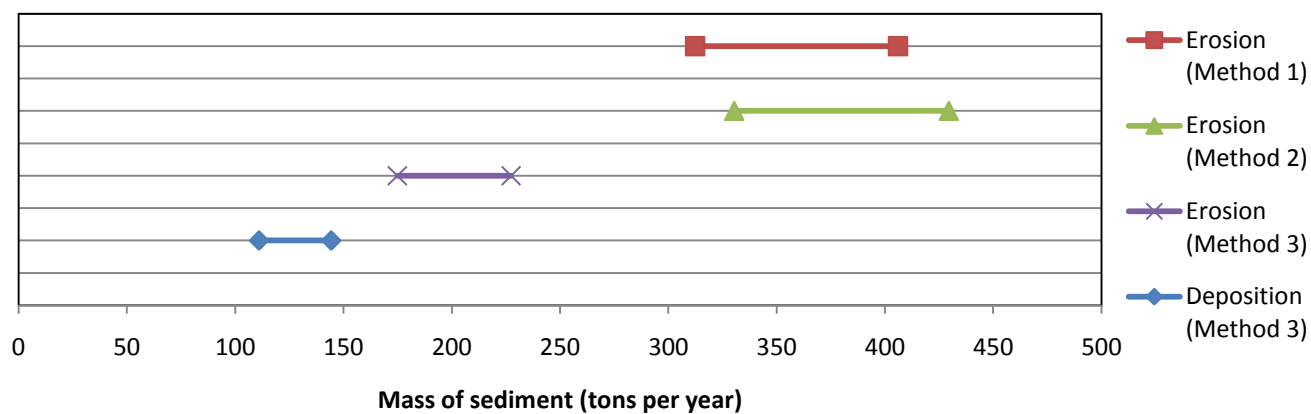
Figure 31. Graph comparing the average amounts of sediment eroded and deposited per year calculated through different methods.

Based on cross sections re-surveyed after six years, the method thought to be the most representative of long-term average rates of erosion, as much as 175 to 227 tons/yr of erosion occurred within the study reach. These values are 58% higher than the estimated amount of deposition within the study reach, and 35-50% higher than the amount of erosion estimated for the study reach from gage station data. Possible causes of this difference are as follows. Much of the sediment eroded from banks might be in temporary storage in the study reach. However, we estimate an amount of storage for bank Type 3 based on rate of deposition along the inside of meander bends from the cross sections, and this amount accounts for the incoming load of sediment ( $95 + 43 = 138$  tons/yr). Furthermore, grain-size data indicate that recently deposited sediment along bank Type 3 is coarser grained than sediment eroded from bank Types 1a and 1b; if so, then the predicted load of fine sediment from bank erosion is even higher than 30 to 139 tons (see Figure 31).
