Issue 24
Spring/Summer 2011

Stream Restoration

Floodplain Restoration: Basics, Benefits, and Practical Applications

**Mark A. Gutshall,
Restoration Ecologist
and Ward L. Oberholtzer,
P.E., Water Resources
Engineer**

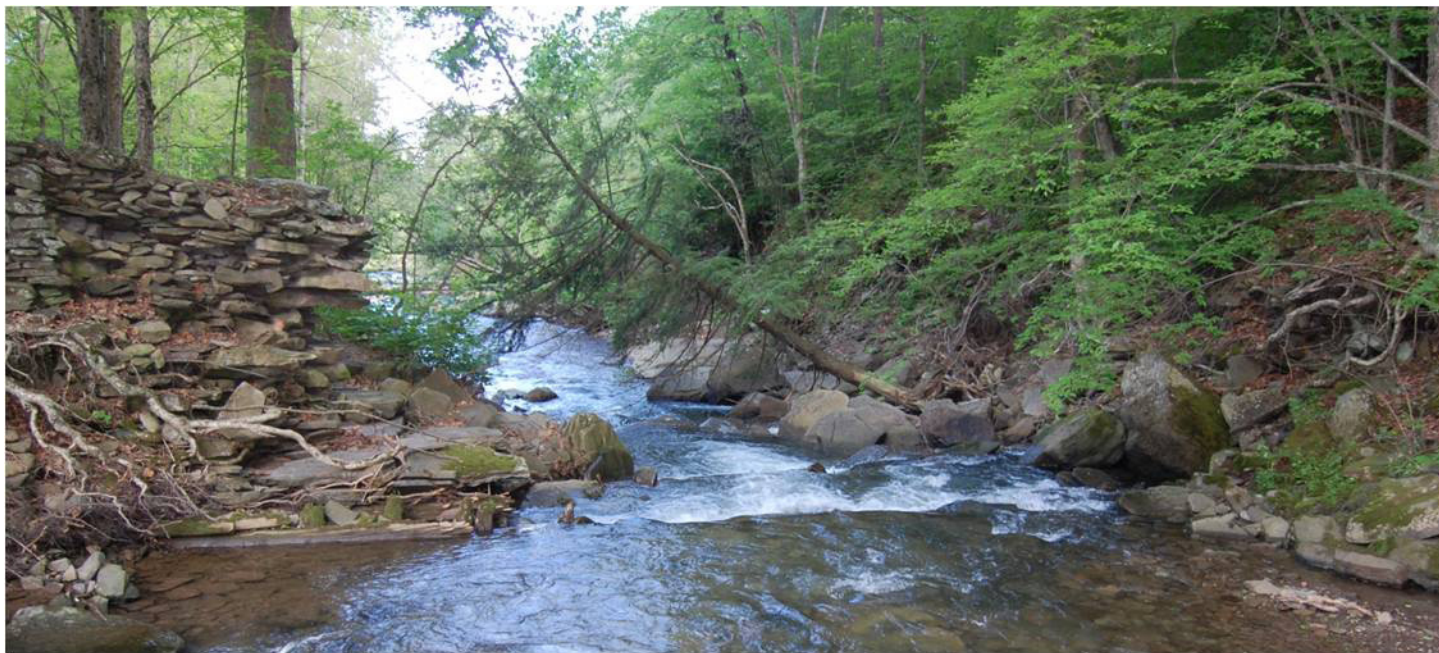
Figure 2. Remains of Breached Dam

This photograph was taken looking downstream at the breached dam breast of a late 19th century dam in Sands Creek, Town of Hancock, New York. Note the high floodplain on the upstream side of the dam.

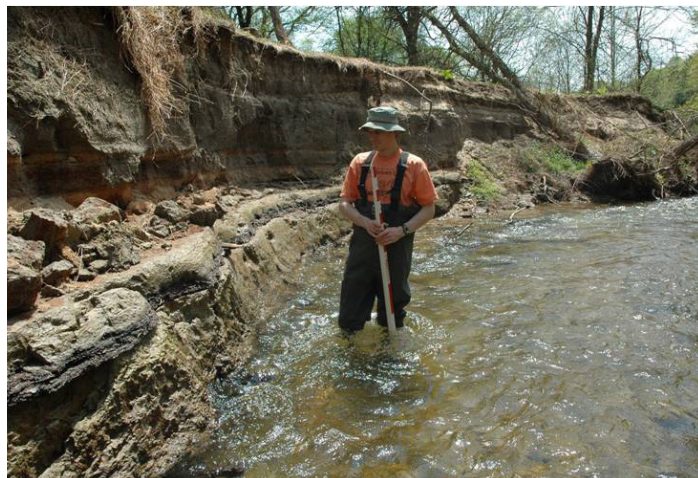
Figure 4. Channel Bank Erosion and Exposed Legacy Sediment. Channel bank erosion and exposed legacy sediments are evident after dam removal in Mount Holly Springs, PA.

After breaching of the dams, the channel eventually cuts down through the legacy sediments to its historical, pre-settlement floor. As a result of the increased channel depth, the gravels along the floor erode easily, allowing the stream to begin undercutting its banks also consisting of fine grained legacy sediments. In Lancaster County, Pa., for example, bank collapse and erosion now occur along at least 80 percent of the 644 miles (1036 km) of stream channels in the Conestoga watershed. We estimate that 10 percent of the sediment stored along valley floors since 1710 has been removed by channel incision and widening that closely resembles arroyo-cutting in the arid southwest (lateral bank erosion rates of >0.5 m/yr measured at multiple sites). The large volume of sediment trapped in the valley bottoms for several centuries has become a major source of suspended sediment load in local streams and in their downstream receiving water bodies during the past 35 years, and will remain so unless substantial remediation efforts are made. This same phenomenon of channel incision, channel bank erosion, and bank collapse is occurring throughout the Piedmont region of Pennsylvania and Maryland, and beyond. (See Figure 4.)

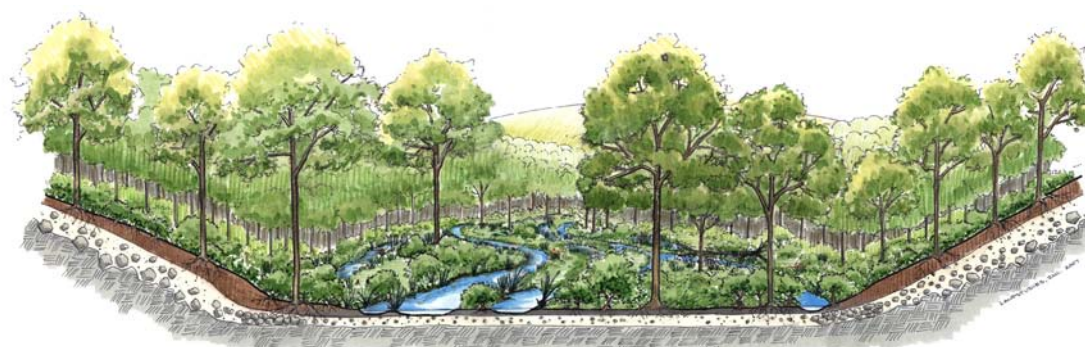
Figure 5. Pre-Settlement and Restored Conditions

Stable, pre-settlement stream and floodplain systems were characterized by: a low, porous floodplain in close contact with surface water in the stream channel, allowing for frequent inundation of the floodplain during high flows; riparian vegetation with roots zones in contact with ground water that enabled groundwater denitrification through root uptake and bacterial processes; and a channel bed composed of cobble and gravel, which helped protect the underlying bedrock from erosive flow forces.

In order to restore a stream, we must first understand what the stream looked like before settlement and land-clearing. (See Figure 5.)

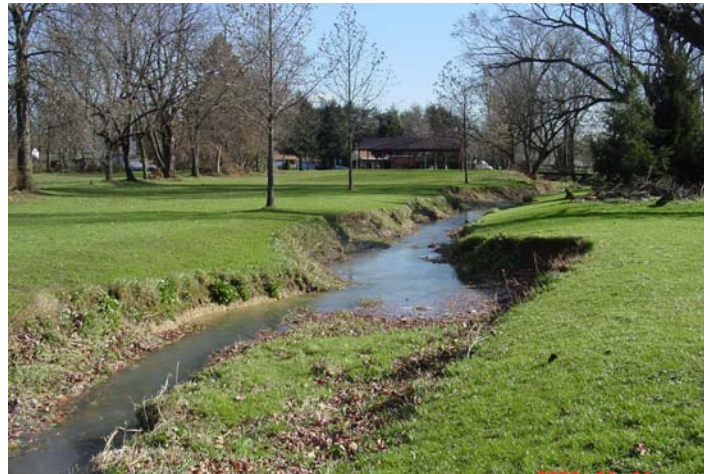
Figure 6. Santo Domingo Creek in New Street Park, Lititz, PA - Before Restoration. The existing stream was channelized, unstable and eroding both vertically and horizontally.

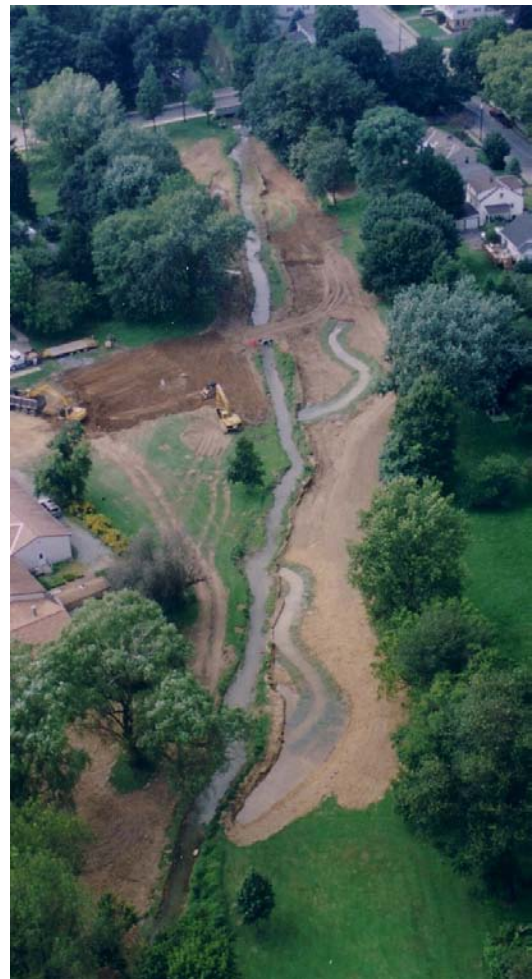
Figure 7. Santo Domingo Creek in New Street Park, Lititz, PA - During Construction. Aerial view shows the new, meandering channel under construction as water continues to flow through the existing straightened channel.

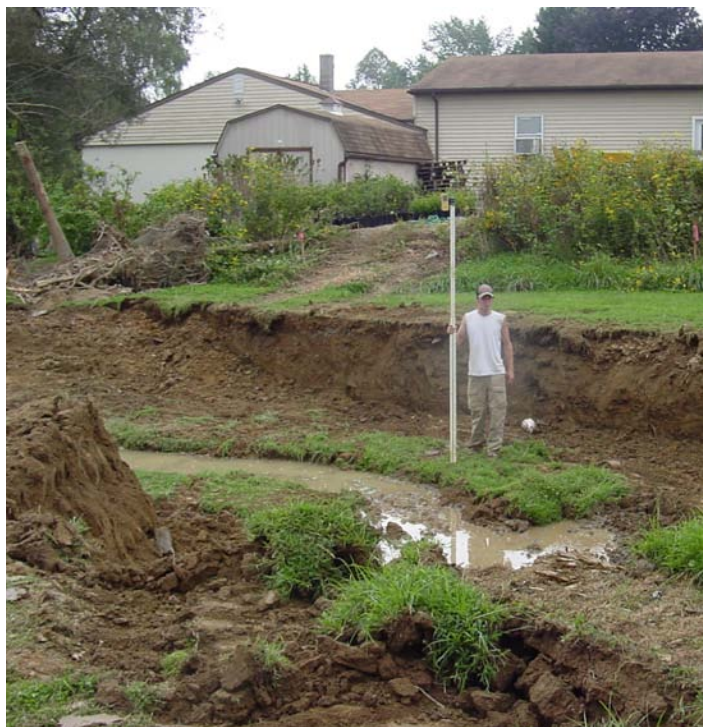
Figure 8. Santo Domingo Creek in New Street Park, Lititz, PA - During Construction. The man is standing on restored floodplain, now attached to the restored channel. The old floodplain elevation, created by the deposition of legacy sediments, can be seen behind him.

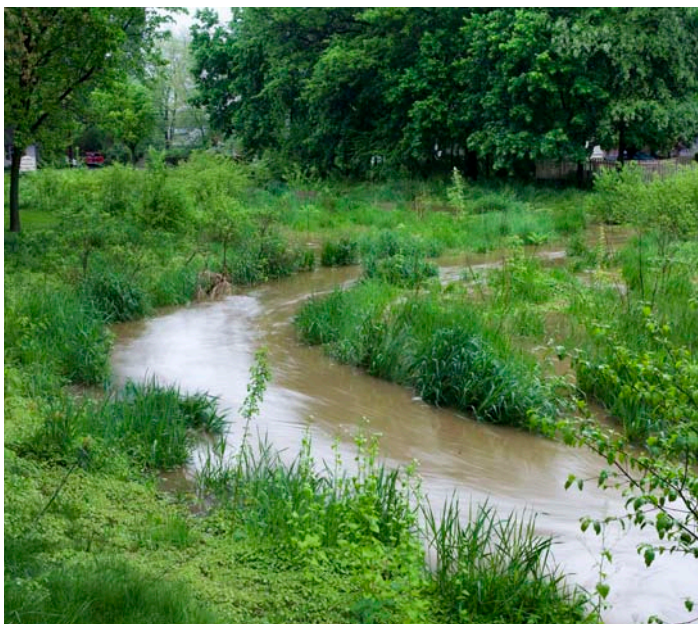
Figure 9. Santo Domingo Creek in New Street Park, Lititz, PA - Post Restoration Restored Condition. The restored site during a late spring storm event.

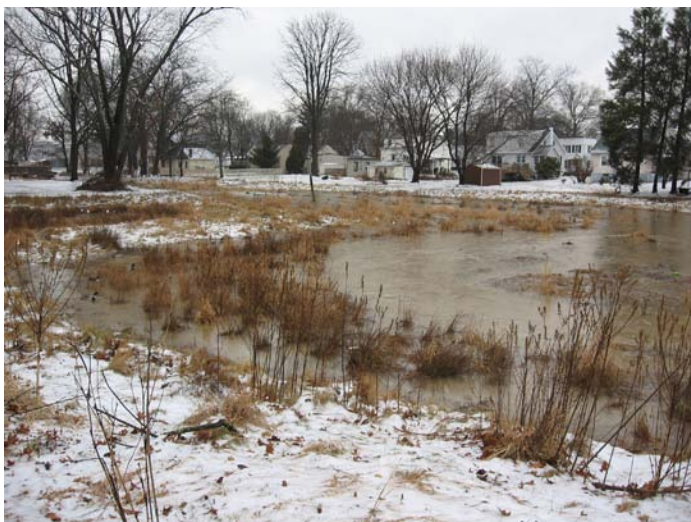
Figure 10. Santo Domingo Creek in New Street Park – Post Restoration Restored Condition. The restored site during a late winter storm event. Notice the restored floodplain receiving flood flows in the now-attached floodplain, where the energy of high flows is dissipated and storage and infiltration can occur.

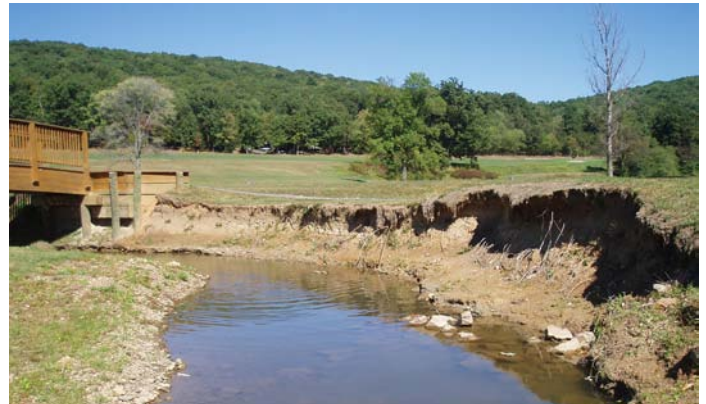
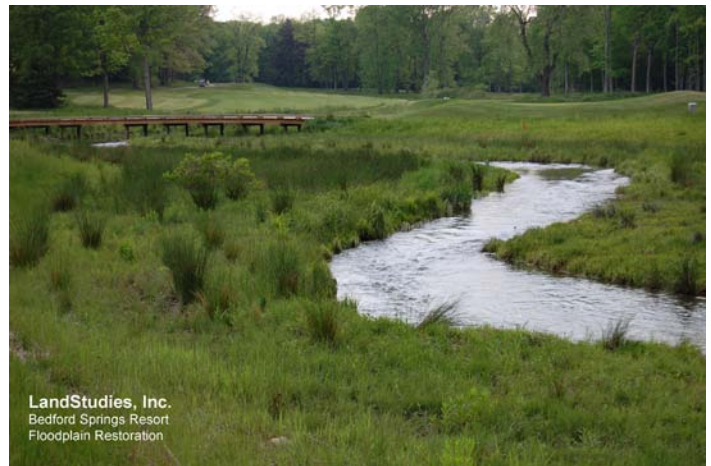
Figure 11. Shobers Run at Bedford Springs Resort – Before Restoration

Figure 12. Shobers Run at Bedford Springs Resort - After Restoration

The golf course associated with the historic Bedford Springs Resort was still in use, but many of the course features were threatened by flooding and erosion which impacted 12 separate holes along Shober’s Run. LandStudies worked with the golf course architect, Forse Design, to incorporate the restoration of the floodplain and stream corridor into the overall design for the golf course. The project involved excavating the floodplain to original elevations to provide storage volume during storm events and to reconnect the floodplain with the stream system. Cart crossings were realigned and designed to accommodate the restoration. The result was 6,800 linear feet of stream restored to a natural flow pattern, 10 acres of created wetlands, and thousands of native plant species planted to restore the floodplain ecosystem. (See figures 11 and 12.)

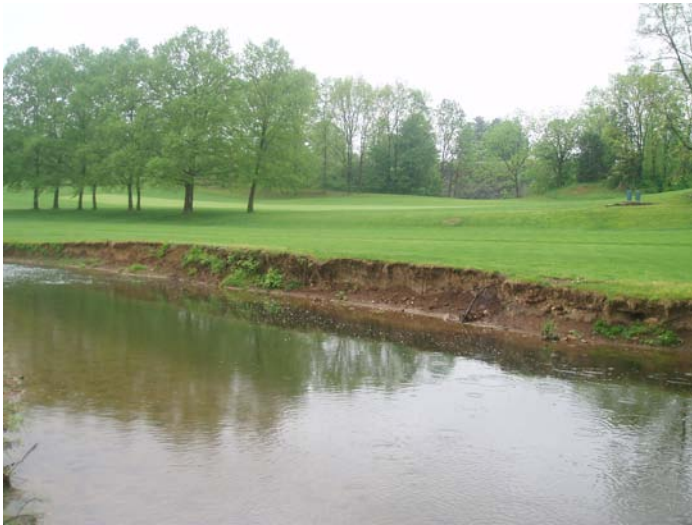
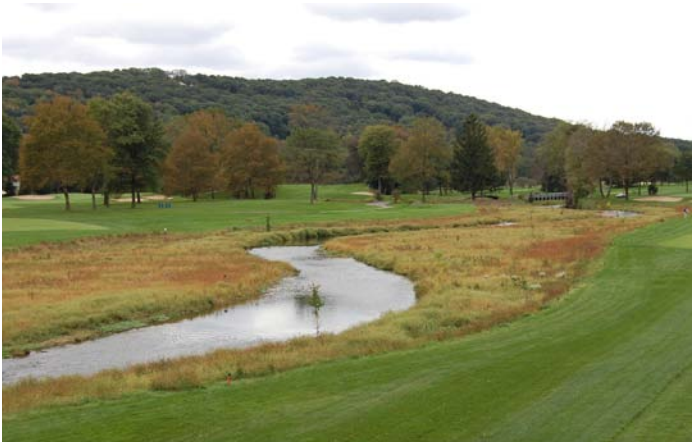
Figure 13. Saucon Creek at Saucon Valley Country Club – Before Restoration

Figure 14. Saucon Creek at Saucon Valley Country Club – After Restoration

Most of Saucon Creek and its tributaries have been constricted, built up and developed with infrastructure affecting the long-term stability of channel reaches within the Country Club site. The challenge was to provide a long-term solution that could be designed, permitted and constructed prior to the 2009 U.S. Women’s Open. The goal of the project was to reduce non-point

source pollution, including sediment and thermal pollution. This was achieved by restoring and stabilizing the stream channel and stream bank and improving the natural floodplain function. The project also re-established wider, more continuous vegetated riparian corridors using native vegetation. The result is improvements in aquatic and riparian habitats, migratory fish passage and wildlife corridors. This project also improved the golf course aesthetics and protects the property and infrastructure from damage from storm events and erosion. (See figures 13 and 14.)

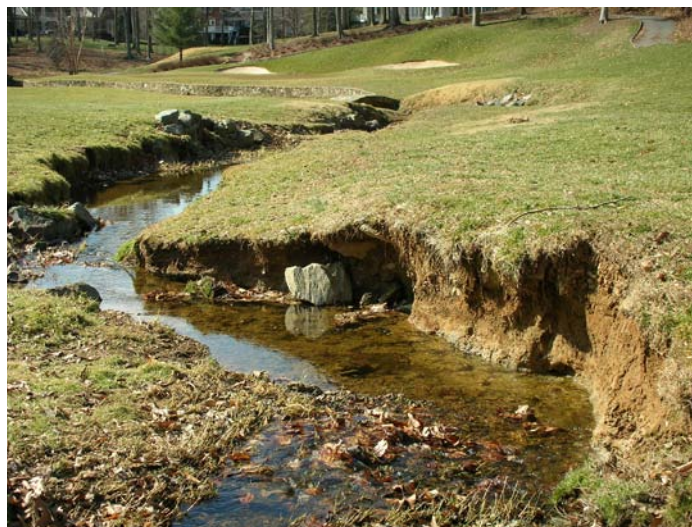
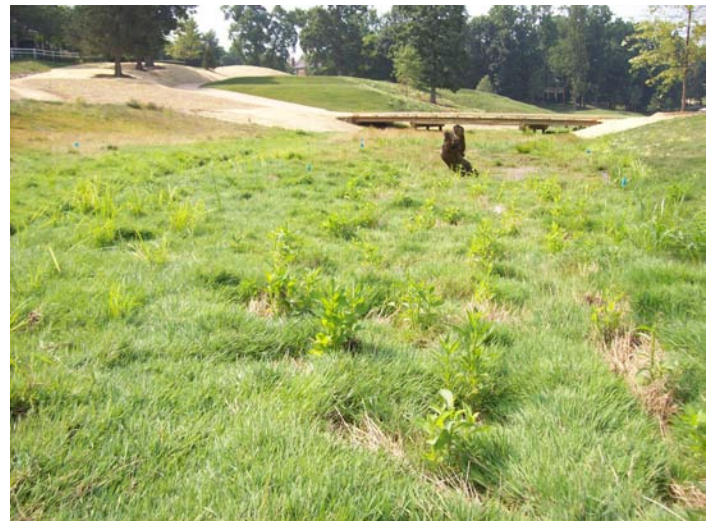
Figure 15. Rock Run at TPC Potomac at Avenel Farms, Potomac, MD – Before Restoration

Figure 16. Rock Run at TPC Potomac at Avenel Farms, Potomac, MD – After Restoration

Flooding and Channel instability along Rock Run made the course unplayable during PGA events. The challenge was to provide solutions for long-term stability and flood mitigation while enhancing play and improving the aesthetics as part of the course renovation in anticipation of a major 2010 PGA event.

LandStudies worked directly with PGA designers to integrate the restoration of Rock Run into the reconstruction of the course. The goal was to improve the aesthetic of Rock Run

while providing stormwater management, reforestation, wetland mitigation and protection of course features during flood events. (See figures 15 and 16.) The result was 7,800 linear feet of stream restoration, 12 acres of floodplain restoration, 9 acres of created wetlands, reduction in the 2, 10, and 100year flood elevations, and native trees and plants were established to restore the floodplain ecosystem.
